Technical Memorandum

Crystal River Ranch White River Shoreline Assessment and Staff/Crest Gage Siting

Drafted November 9, 2012 Review / Edit February 9, 2013

To: Crystal River Ranch Executive Board
From: Lawrence Dominguez, Owner, Senior Aquatic Ecologist
RE: River Shoreline Assessment and Staff/Crest Gauge Recommendations

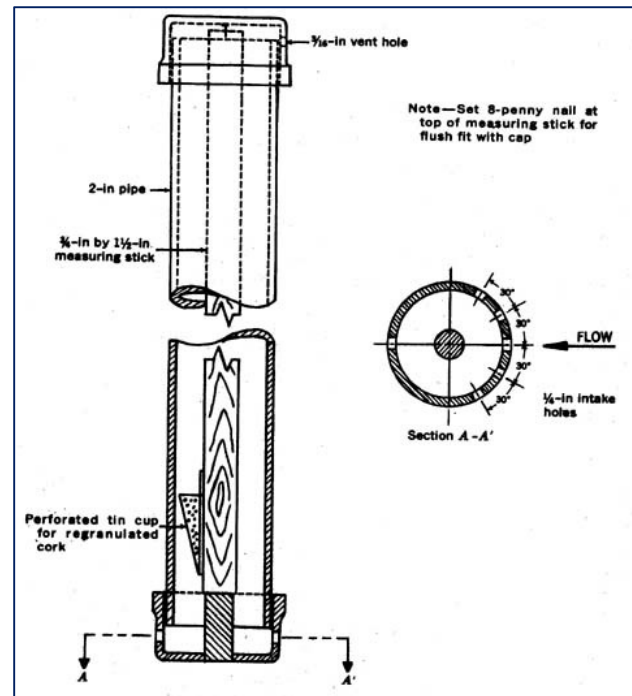
Another low cost option is the Crest-stage gage (right) that obtains the elevation of the flood crest. This economical, reliable, and easily installed gage is the minimum recommendation for CRR reach management. A vertical piece of 2 inch galvanized or plastic conduit pipe with a wood staff held in a fixed position with relation to a datum reference would be appropriate. The USGS is aware of survey monuments in the area so that the gage can be tied to regional datum (standard position that measurements are obtained). The bottom cap has six intake holes located so as to keep the non-hydrostatic drawdown or superelevation (climbing up the staff or pipe wall) inside the pipe to a minimum. Tests have shown this arrangement of intake holes to be effective with velocities up to 10 feet per second, and at angles up to 30 degrees with the direction of flow.

The bottom cap contains re-granulated cork. As the water rises inside the pipe the cork floats on the water surface. When the water reaches its peak and starts to recede, the cork adheres to the staff inside the pipe, thereby retaining the crest stage of the flood. The gage height of a peak is obtained by measuring the interval on the staff between the reference point and the floodmark. EcoAssets and associates are capable of selecting, purchasing, installing and calibrating the preferred system.

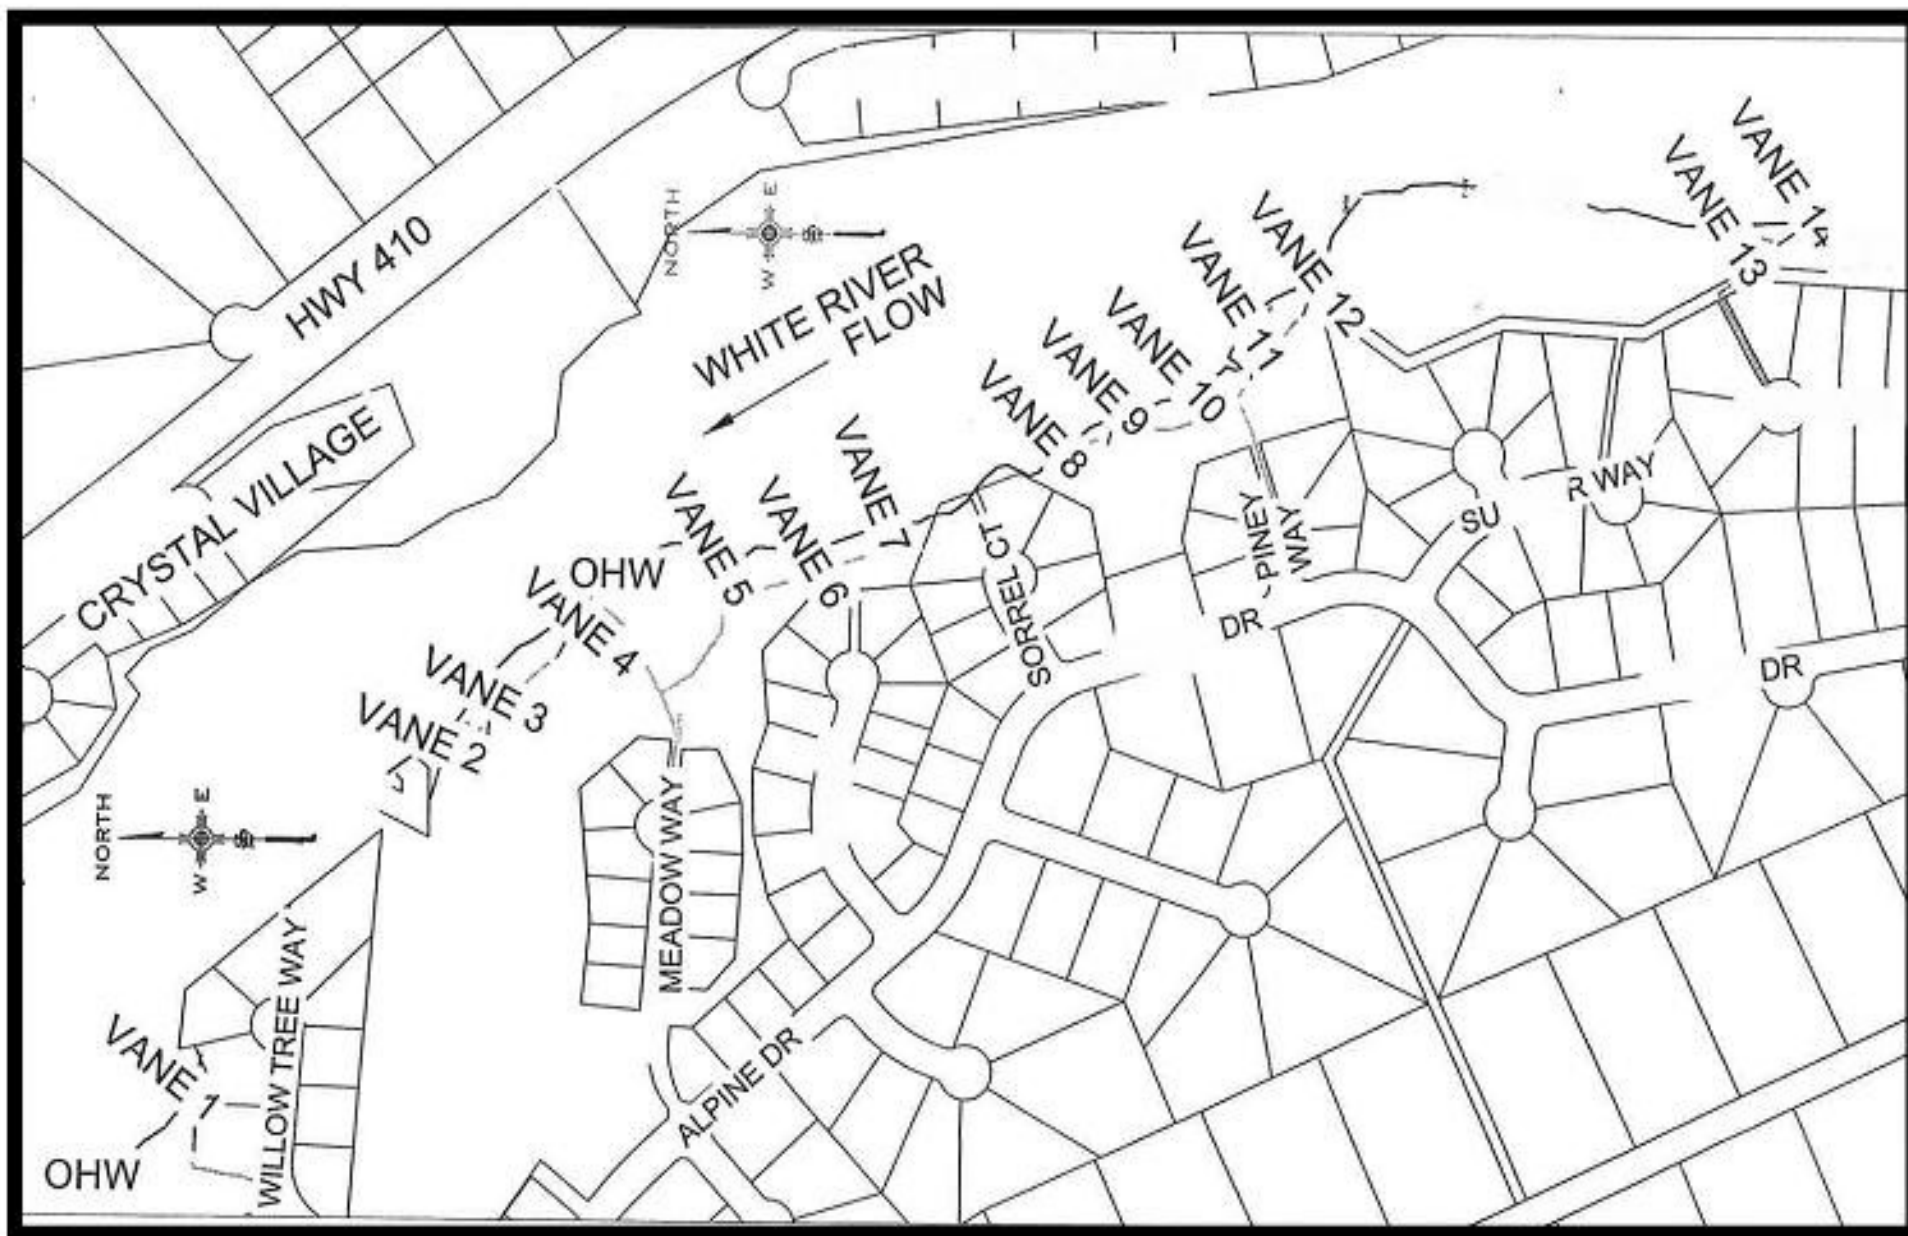
Vane Cluster 1	Rock-Vane 1
Vane Cluster 2	Rock-Vanes 2, 3, and 4
Vane Cluster 3	Rock-Vanes 5, 6, and 7
Vane Cluster 4	Rock-Vanes 8, 9, 10, 11, and 12
Vane Cluster 5	Rock-Vanes 13 and 14

Figure 1. Rock-vane locations on southwest bank of White River. Groupings; 1; 2-4; 5-7; 8-12; 13,14.

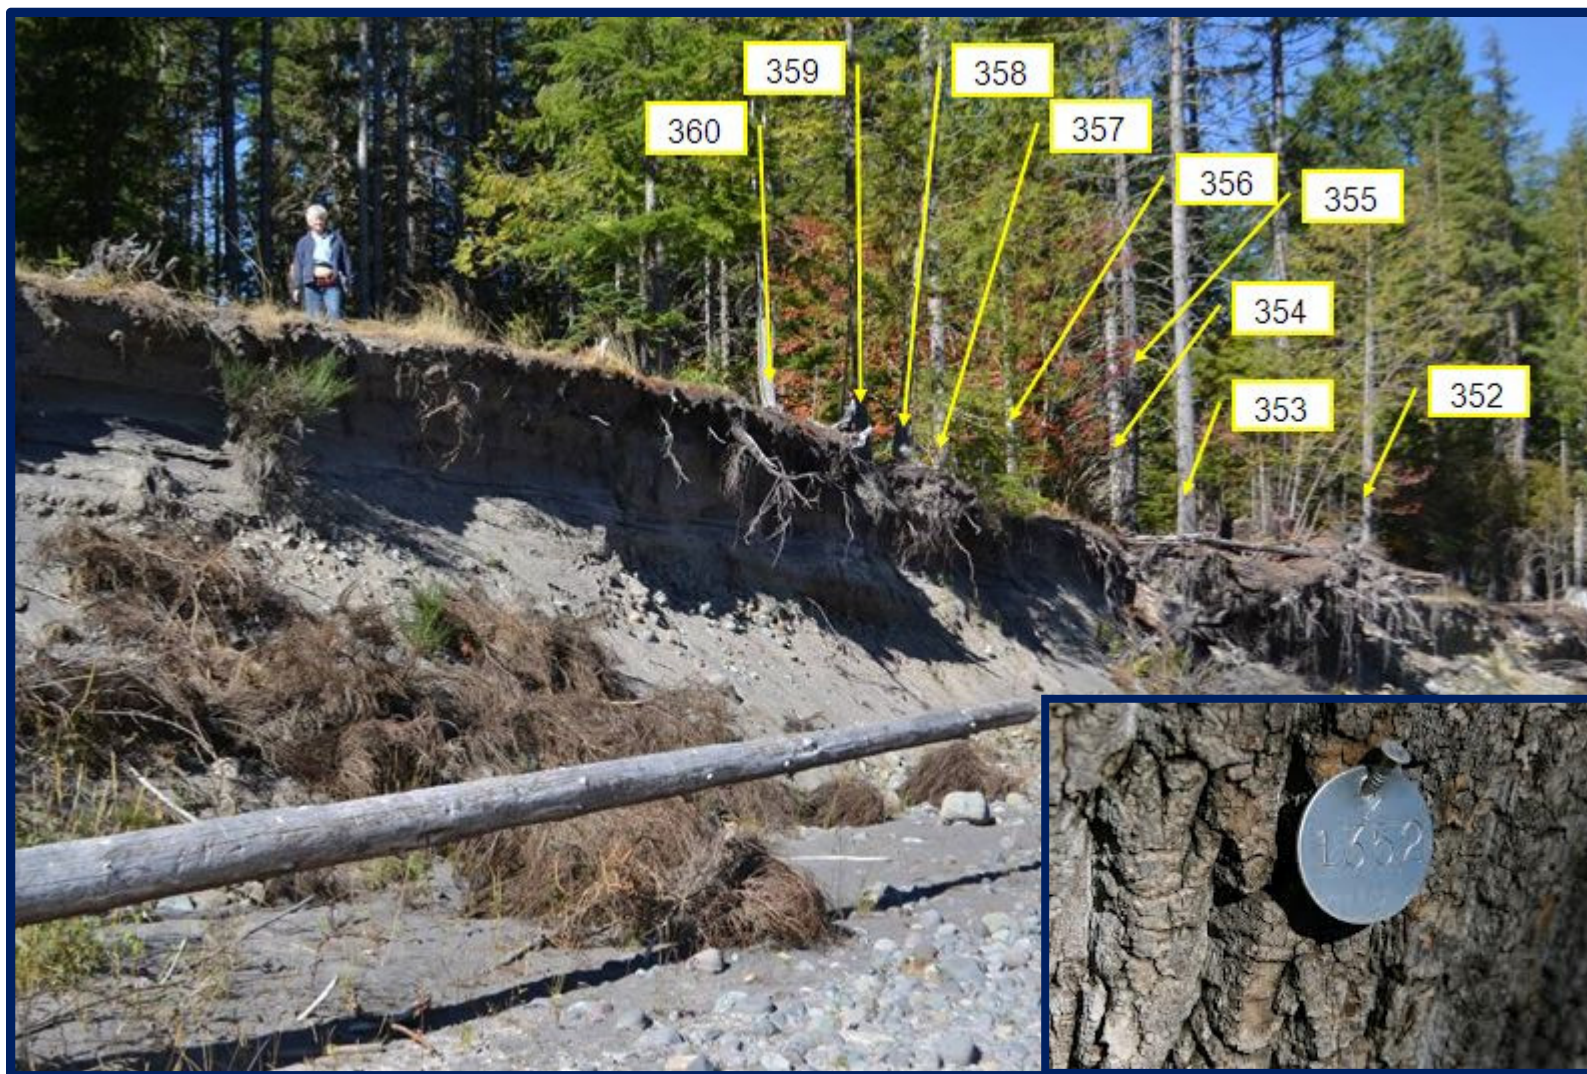
Figure 4. Example of how trees in vicinity of a rock-vane can be tagged and used as erosion markers with location tied into survey. Pre-numbered aluminum tags are recommended and installed on each selected marker tree with location correlated to rock-vane reference markers. Note aluminum nail not fully driven in to accommodate tree growth.

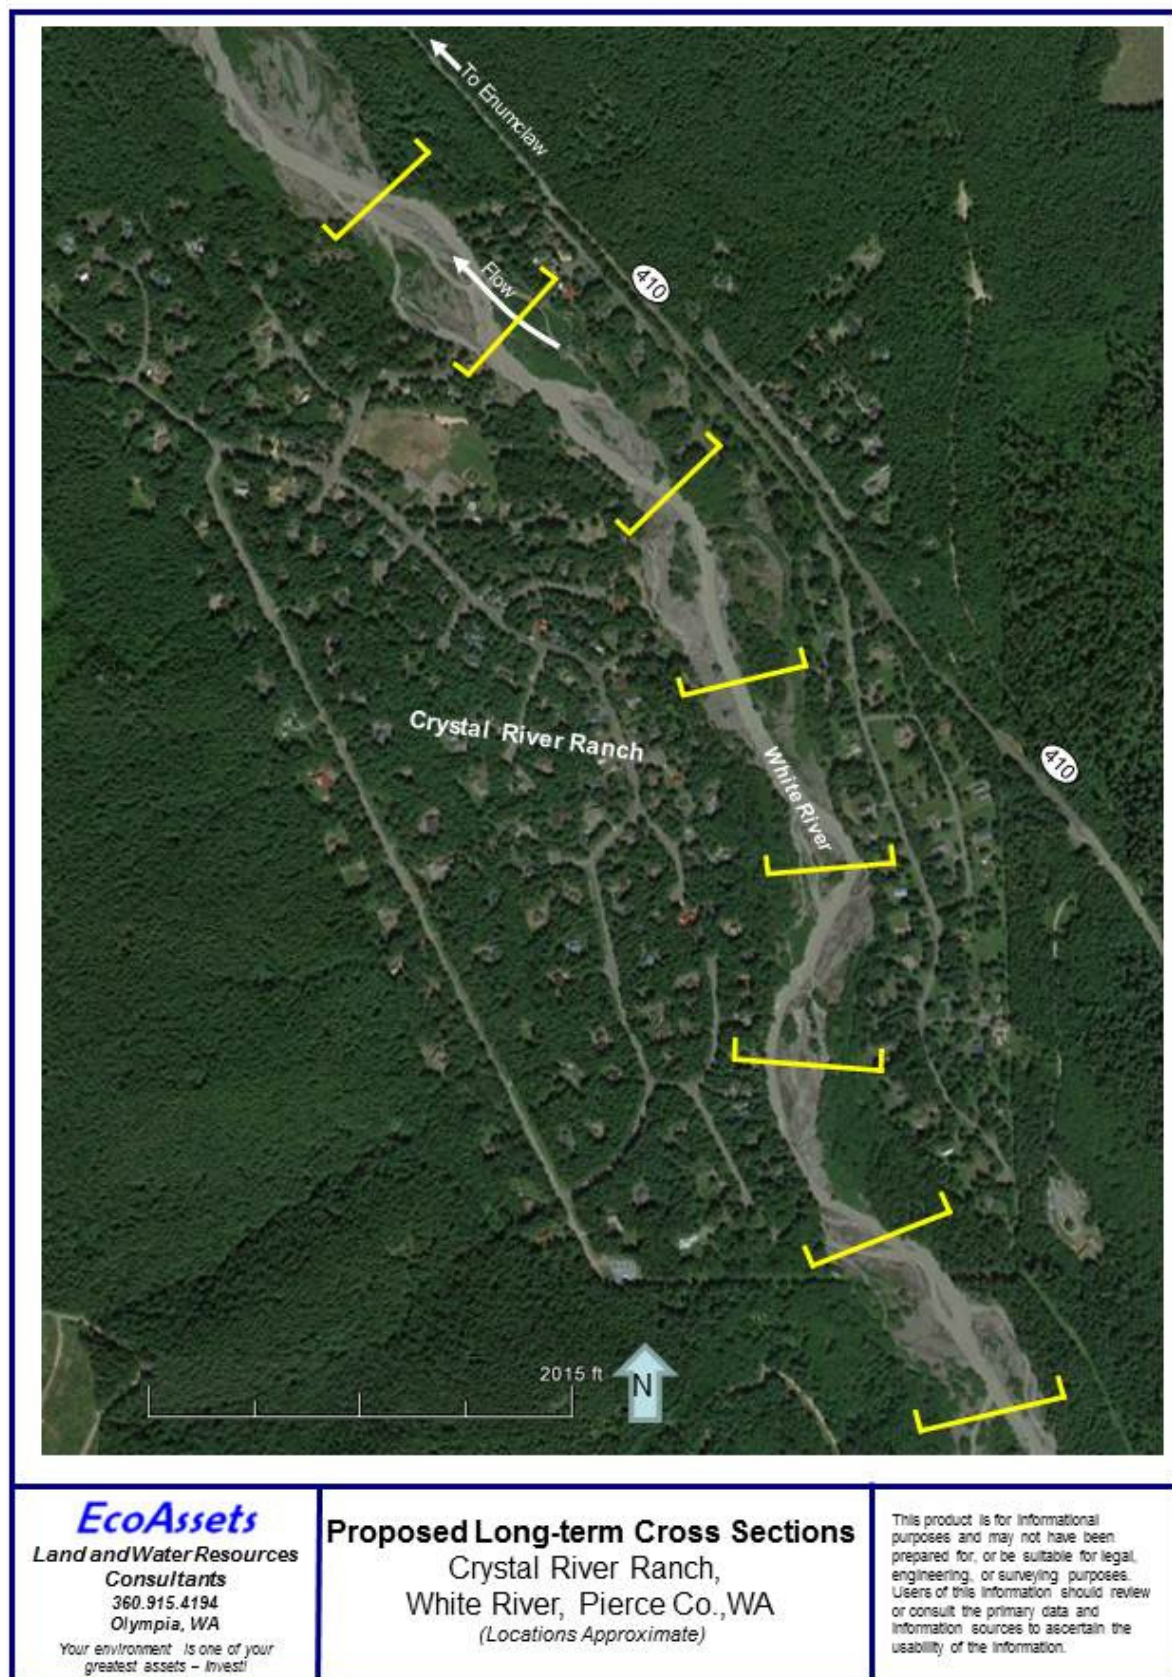
Figure 5. Proposed channel cross-section locations.

EcoAssets recommends that up to 8 channel cross-sections be established slightly upstream, downstream, and within the project area to establish width/depth ratio (Figure 5 for concept location and spacing). Width/depth ratio is a key variable for assessing departure from a stable reference condition. Increases in W/D ratio generally are associated with accelerated streambank erosion rates, excess deposition/aggradation processes, and over-widening. Cross section endpoints should be placed landward of the bankfull width (the maximum width of a stream) and include a reading at the bankfull width. The bankfull width is essentially the point along the bank where, during high flows, water exits the channel. A laser range finder or for more accuracy, a tape measure stretched from one bank to the other at 90° to the general course of the river, will provide the measurements to record bankfull heights. Bankfull height, the measurement from the stream bottom to the horizontally projected bankfull width elevation, should be taken at changes in topography or bathymetry in a frequency that captures the general streambed cross-section profile. A 1,000 foot spacing of cross sections based on mid-channel lineal distance can provide cross-sectional profiles for future comparison. Some cross sections from the 2008 surveys can be maintained since they could provide a 5-yr. monitoring interval (if surveys occurred in 2013). The cross-section spacing and locations would be adequate for use in hydraulic modeling should that be necessary for project design or effects analysis in the future. If opposite bank benchmarks established such as driven in the ground rebar flagged stakes, they should be negotiated with landowners first since many of the cross section measurement markers will be on private or communal property.

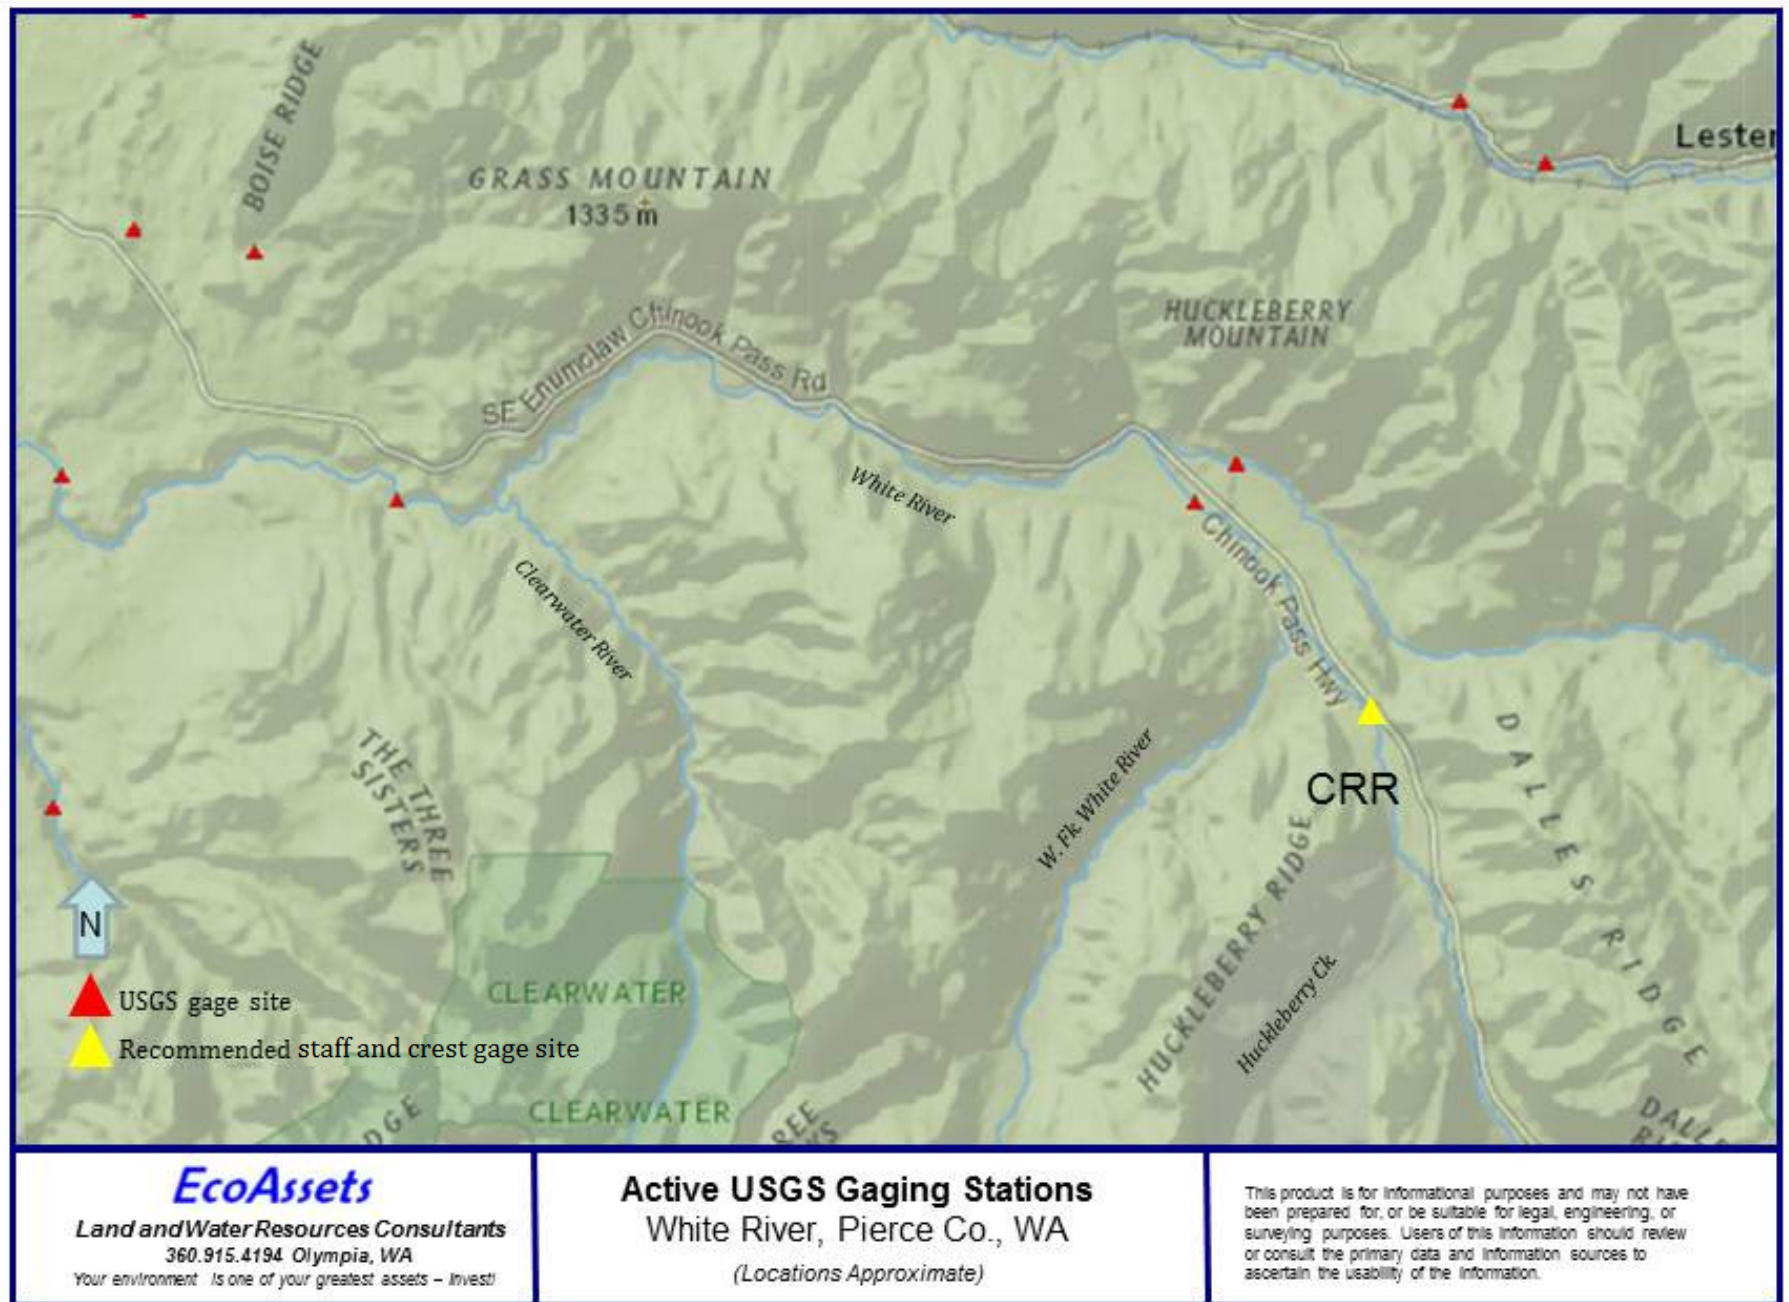
There are active USGS-managed streamflow gages in the White River and tributaries upstream of Mud Mountain Dam (Figure 6). They are:

Figure 6. Active USGS stream gage stations and proposed location of additional gage

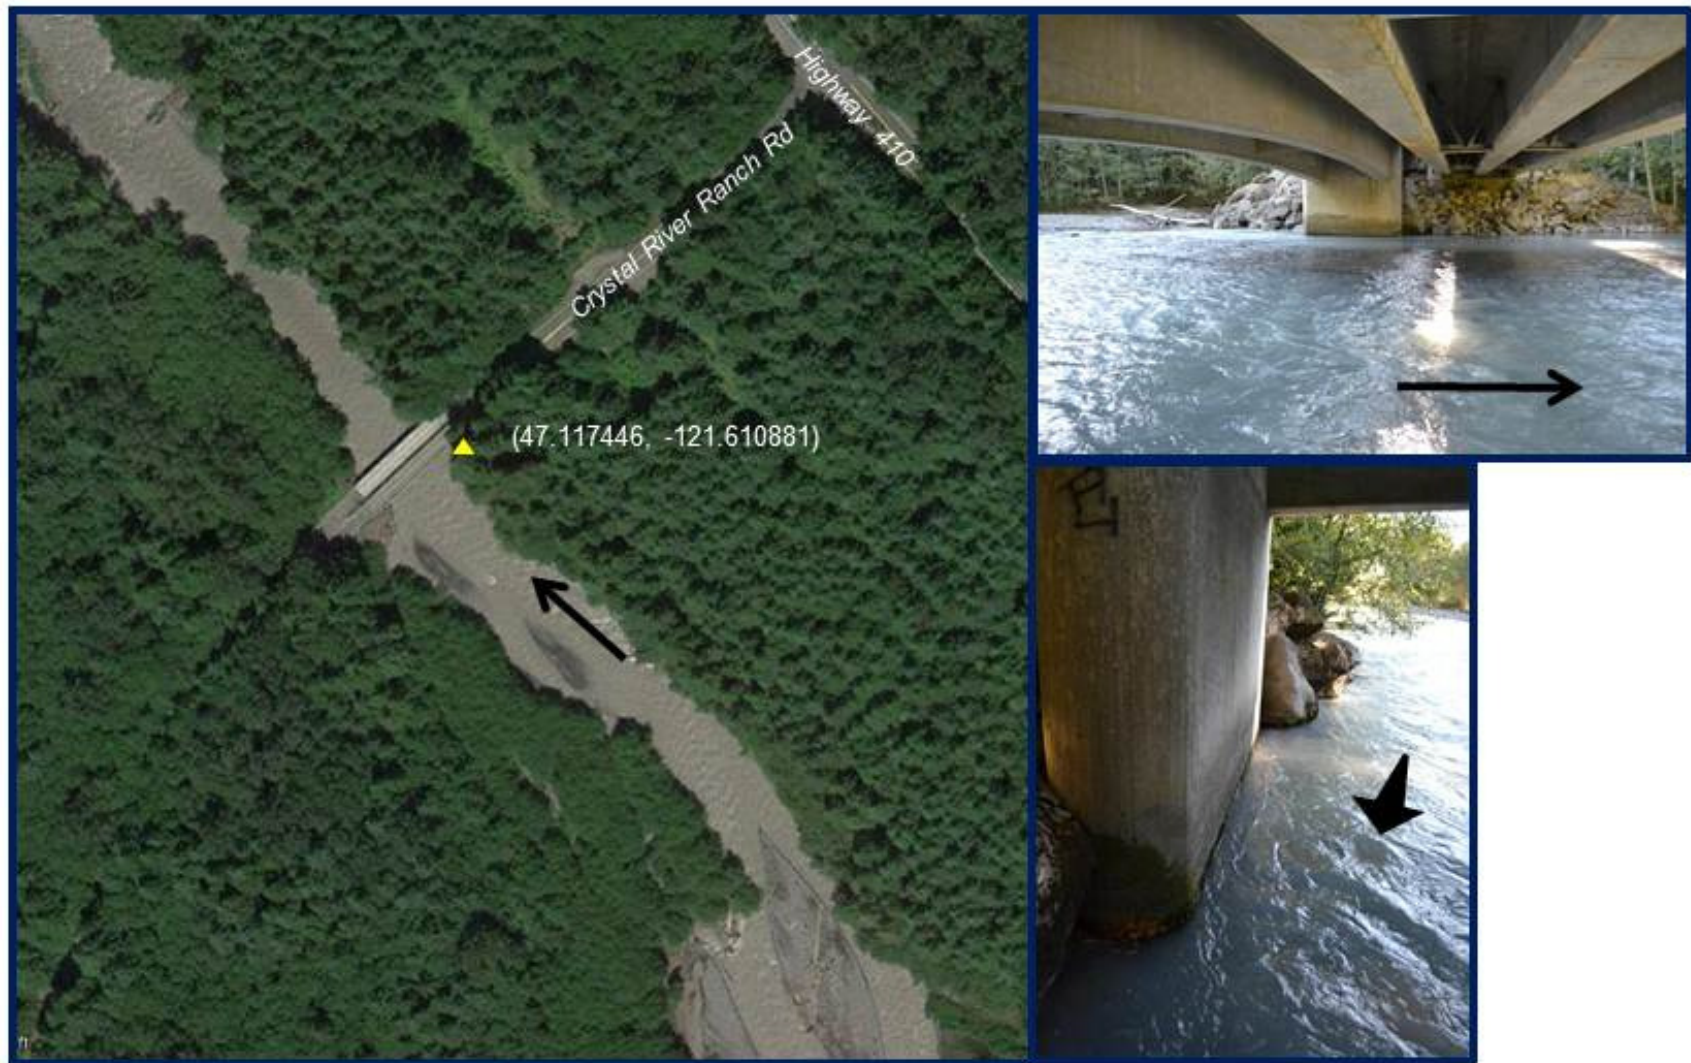
Figure 7. Proposed location of gage site (yellow marker with coordinates in decimal degrees) on Crystal River Ranch Road and view under the bridge. The staff gage should be placed so it is observable from the bridge or bank in a safe location during high flow events.

Based on the need for more localized and accurate flow measurements for long-term CCR reach management, a stream gage at Crystal River Road crossing is recommended for installation (Figure 7). The site fits many traditional requirements of gage siting including:
