Crystal River Ranch Upland Erosion Control Project

December 2014 CRR Restoration Status Report

PALS Permit No. 695650, Development Eng. File No. 56-15

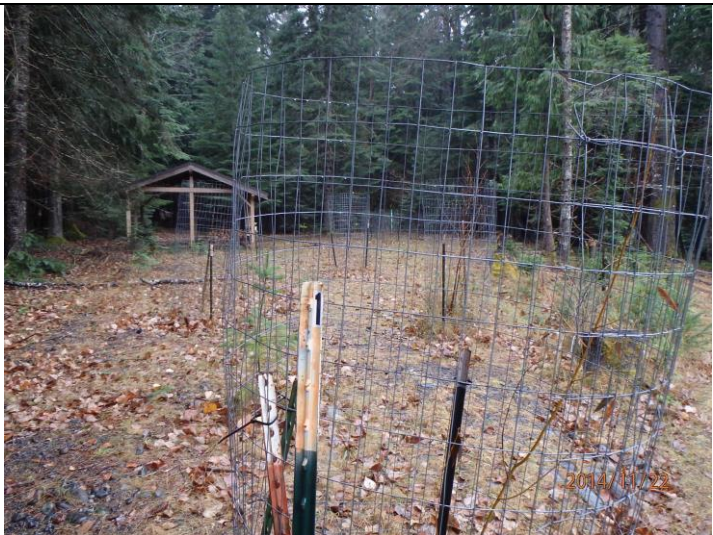
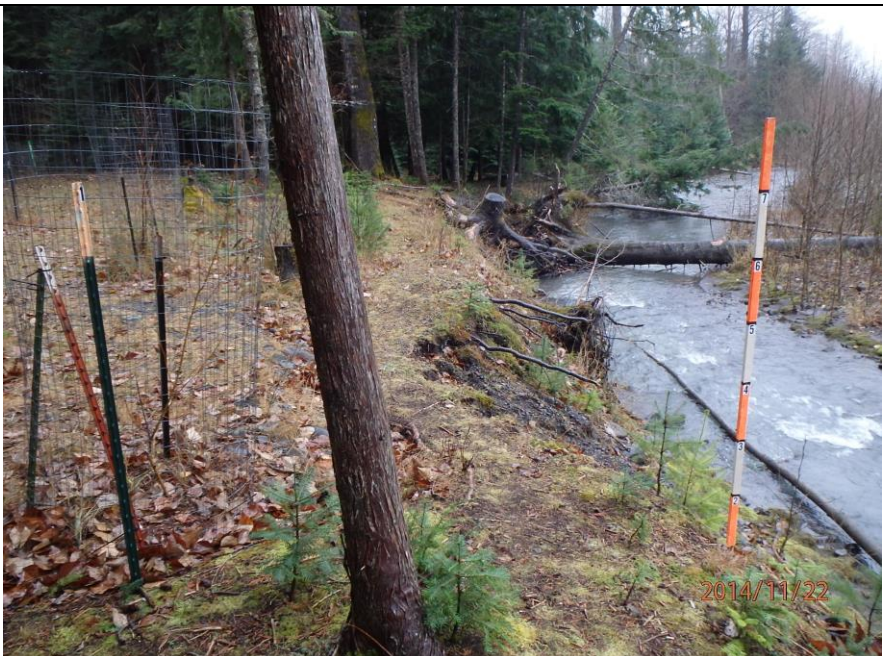
V1 Downstream 11/22/2014

Sitka willow	3-4 ft	Fair	1	Planted Apr 2011 = 40	
Birch	6-7 ft	Fair	17	Vane 1 plant survival exceeds 80%	
Birch	4-5 ft	Fair	2		
Doug fir	4-5 ft	Good	2		
	2-3 ft	Good	13		
	2-3 ft	Fair	4		
	1 ft+	Good	6		
Live plants:			45		
<p>N 47° 06.654', W 121° 36.305' at shoreline vane stake (toe end).</p> <p>3 Foot approximate OHW (ordinary high water) bank height.</p>

Vane 1 live plants quantity 45 divided by planted April 2011 quantity 40 exceeds 80%+ survival

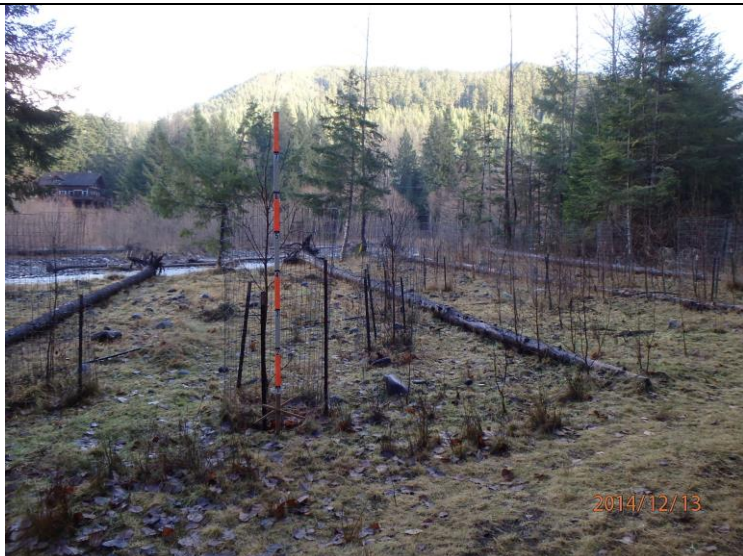
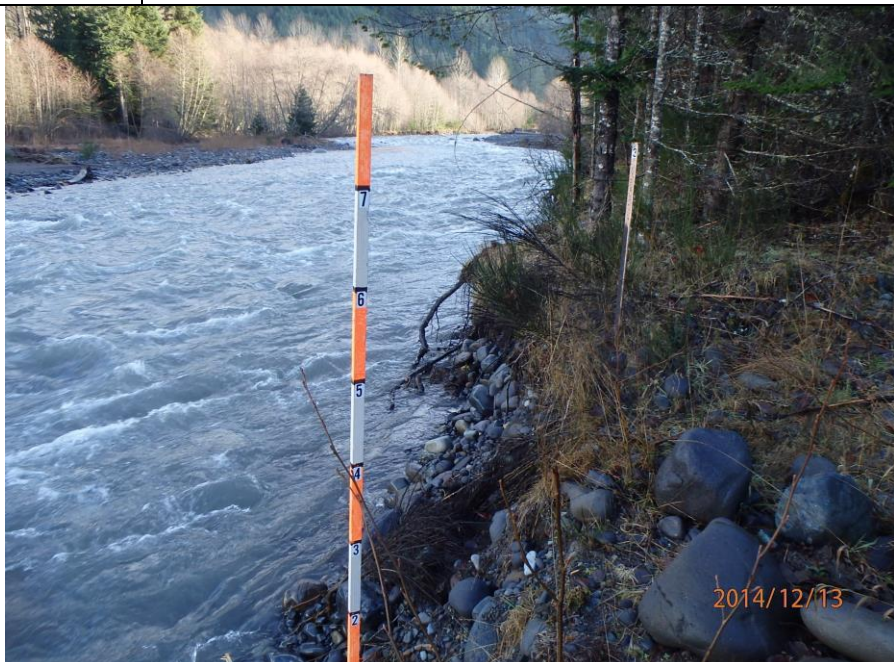
V3 Upstream 12/13/2014

Sitka willow	4-6 ft	Fair	3	Planted Apr 2011 = 43	
Birch	7-8 ft	Fair	9	Vane 3 plant survival exceeds 80%	
Birch	5-6 ft	Fair	10		
Doug fir	2-3 ft	Good	2		
Alder	7-8 ft	Good	3		
Alder	4-6 ft	Good	54		
Live Plants:			81		
N 47° 06.560', W 121° 36.106' at shoreline stake (toe) of vane.

Vane 3 live plants quantity 81 divided by planted April 2011 quantity 43 exceeds 80%+ survival

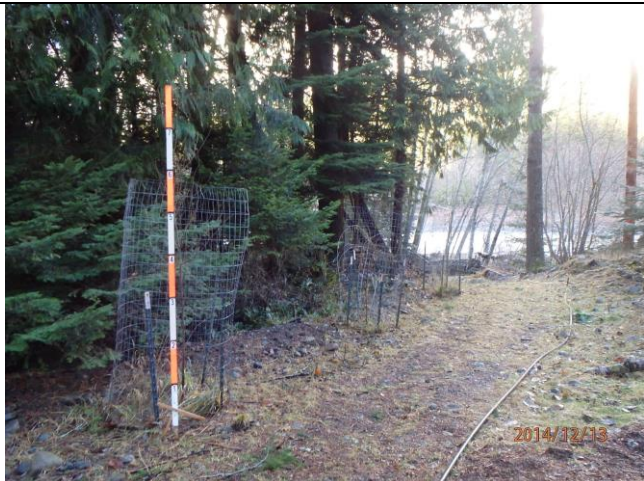
Access V2-4 12/13/2014

V2 - 4	Birch	8-9 ft	Fair	2	Planted Apr 2011 = 6	
V2 - 4	Birch	6-7 ft	Fair	3	Access route plant survival exceeds 80%	
Live Plants:				5

Access route live plants quantity 5 divided by planted April 2011 quantity 6 = 83%+ survival

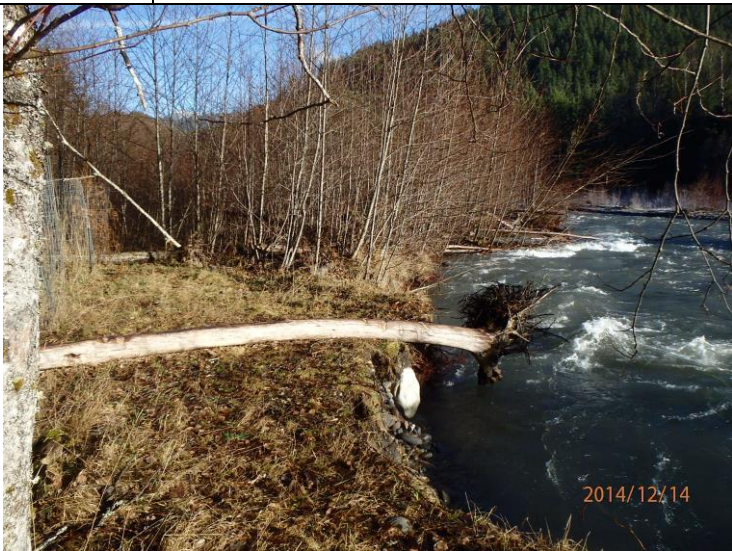
- July - December 2014 Resident elk herd consuming Birch and Sitka willow branch growth outside protective cages. Douglas fir replanting = 4. Majority of scotch broom pulled at all vane sites. Vane 14 shoreline 18 ft. to 20 ft. eroded since 2010. At vane 14 toe rock is exposed and 1 mature shoreline 2010 Alder lost Nov 2014 and another 2010 mature Alder in upstream proximity Dec 16, 2014 leaning over channel.

Sitka willow	4-6 ft	Fair	4	Planted Apr 2011 = 24	
Birch	10-12 ft	Good	8	Vane 14 plant survival exceeds 80%	
Birch	6-7 ft	Good	6		
Doug fir	4-6 ft	Good	3		
Alder	4-6 ft	Good	2		
Alder	2-3 ft	Good	5		
Live Plants:			28		
<p>N 47° 06.148', W 121° 35.395' at shoreline vane stake. Furthest upstream inland rock vane. At site main channel bends West to East.</p> <p>3 Foot OHW bank height.</p> <p>18 ft - 20 ft shoreline erosion since 2010. A vane toe rock exposed. One mature shoreline alder lost 2014 and another mature alder in upstream proximity leaning over channel.</p>

V14 Toe Stake Lost to Erosion 12/14/2014
