## TECHNICAL MEMORANDUM

September 13, 2014

RE: Vane Monitoring Reference Point and Top of Undisturbed Left and Right Bank Survey, Crystal River Ranch Reach White River, Pierce County, WA

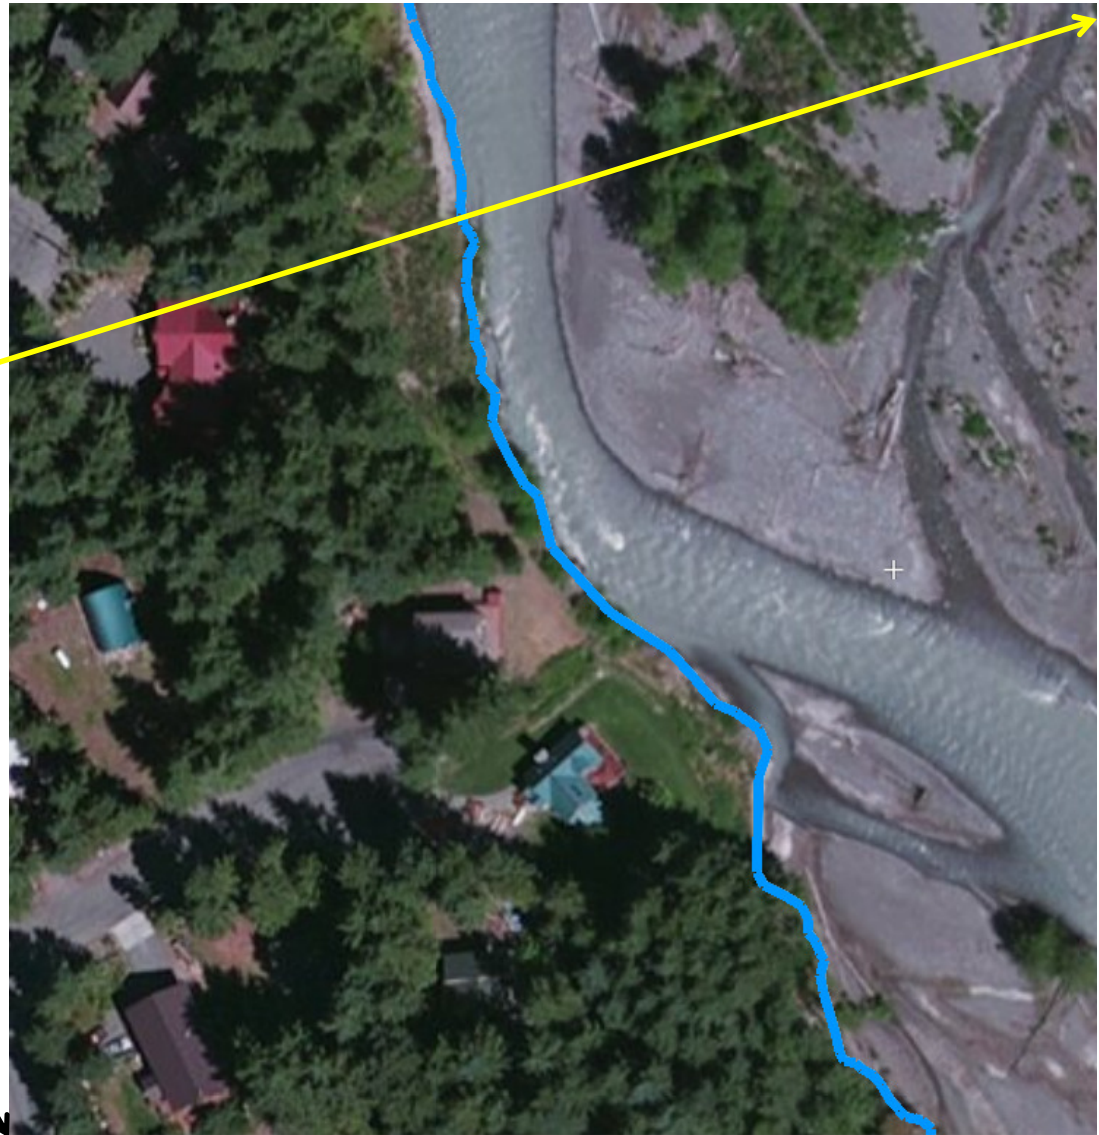
Blue line represents a composite of all GPS points from November 2013 top of undisturbed bank survey. Top of undisturbed bank survey is repeatable and can be compared over time to estimate the erosion rate.
