To: Crystal River Ranch Shoreline Stabilization Committee

From: Lawrence Dominguez, Owner, Sr. Ecologist

RE: River Shoreline Project Evaluation, September 24 – 25, 2016

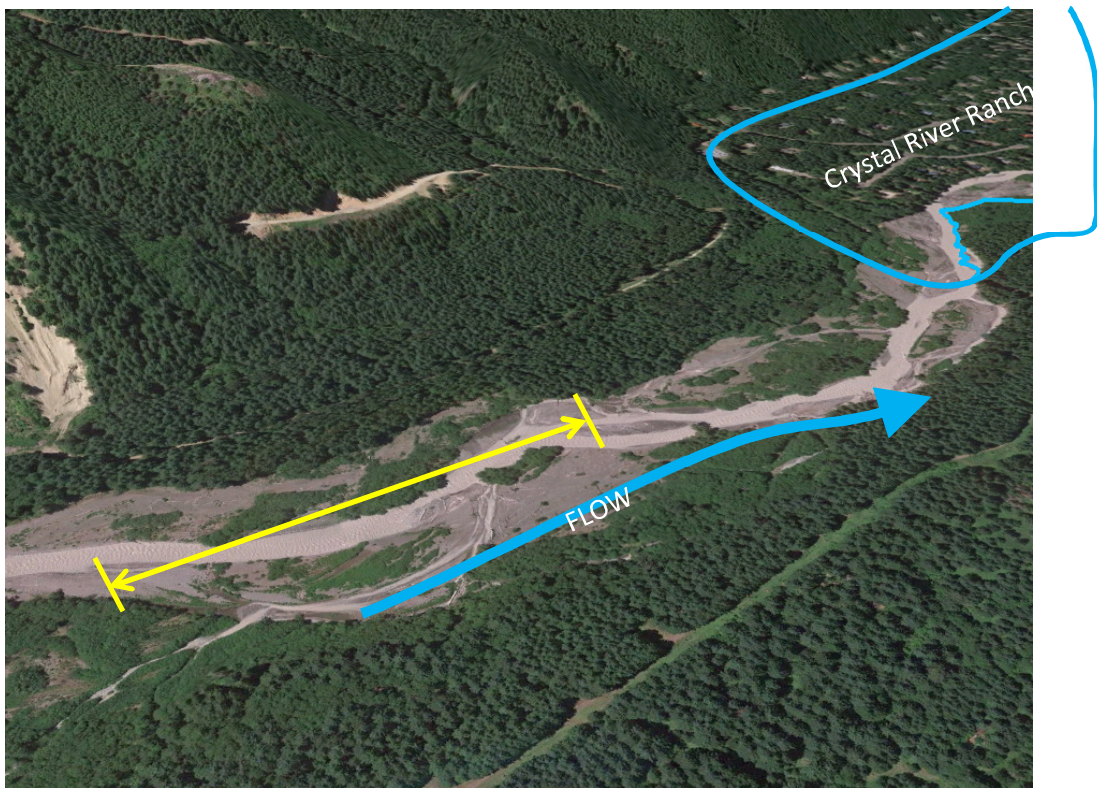
We visited the left bank of the White River (CRR side) channel about ½ mile upstream from the power station (Figure 1). The left bank of this area is heavily forested and located on secondary floodplain. There is evidence of historic channels but high bank areas and mature forest suggest that many decades of erosion with the channel abutted against the left bank could establish a moderate risk to avulsion. There is only a low risk given the current channel trend.

Figure 1. Upstream area visited by CRR Assessment team to determine level of channel avulsion risk and exposure risk to Elk Trail Way area of Crystal River ranch. Yellow line indicates site visit area September 25, 2016.

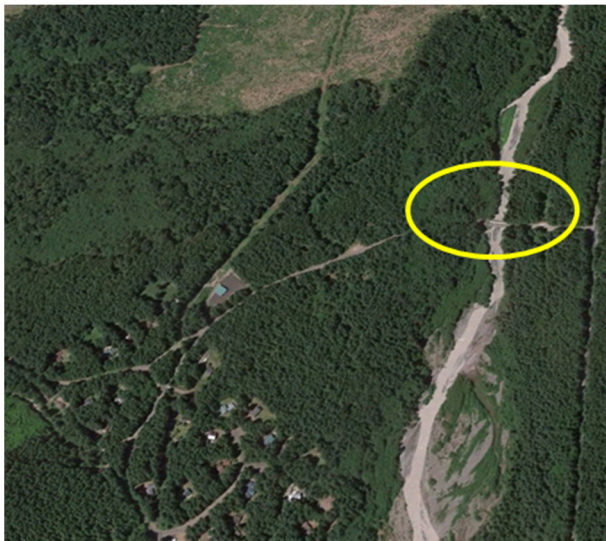
We also visited the downstream Crystal River Ranch Rd East entrance to Bridge (Figure 2). The relatively narrow bridge span (79 ft. abutment to abutment) suggests that the constriction could be contributing to higher than normal sediment deposition rates in the CRR reach compared to if the bridge did not constrain the active channel.

Figure 2 Crystal River Ranch Road crossing of White River

3. There is evidence of backwater during certain flood stages at the entrance bridge upstream of the CRR road. The team agreed that placing crest gauges in the floodplain below the bridge would provide good baseline information about the effects of an undersized bridge. The team suggested that EcoAssets help install the low-cost gauges this fall and provide the survey and map work.
