**White River Shoreline Erosion
Hazard Assessment and
Monitoring Report #3**
**Crystal River Ranch Homeowner's
Association**

Pierce County, WA
June 2017

Photo Log White River Shoreline Assessment May 16, 2017

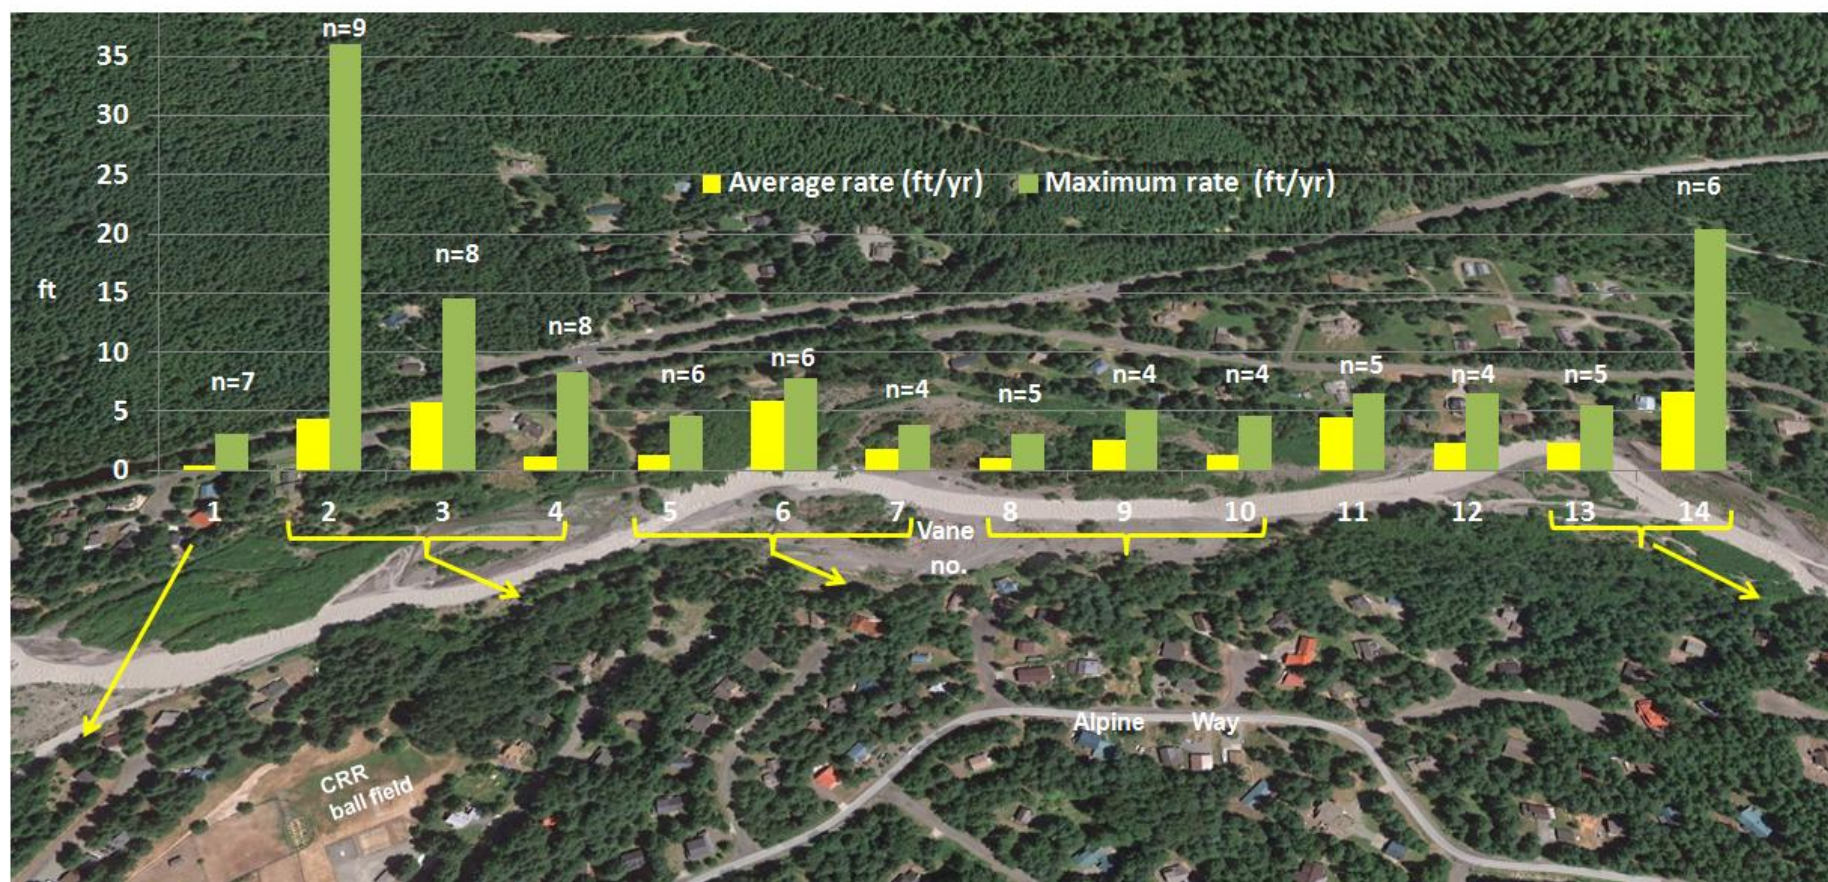
Estimated Bank Erosion Rate (ft/year) Fall 2013 – Spring 2017 Crystal River Ranch

79 tree tags have been installed in the project reach, The arrows indicate approximate locations of a rock vane or group of vanes. The number of tree tags varies per vane. The average rate is the average of all tree tags assigned to a vane. The maximum rate is the highest measurement of one tree tag marker for a particular vane. The number of tree tags per site is represented by n.

Seventy nine reference markers placed on trees were used to measure changes in the top of bank location. The maximum bank loss rate per year was estimated by analyzing each reference marker over time. Three sets of measurements have been made; November 1, 2013, September 24, 2016 and May 16, 2017. The highest rate of erosion observed in this period of baseline assessment was 36 feet/year at Vane 2. The overall average for all sites was 3 ft/year.

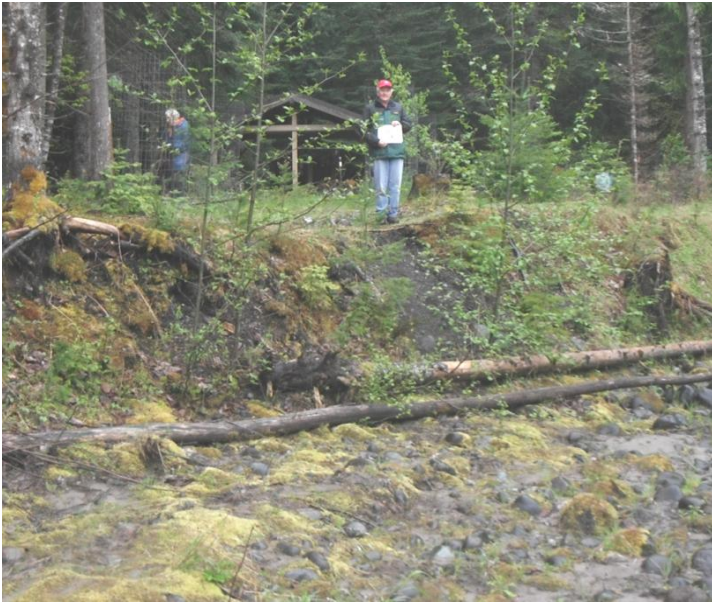
Vane 1 area has no erosion evidence and setback from the active channel.

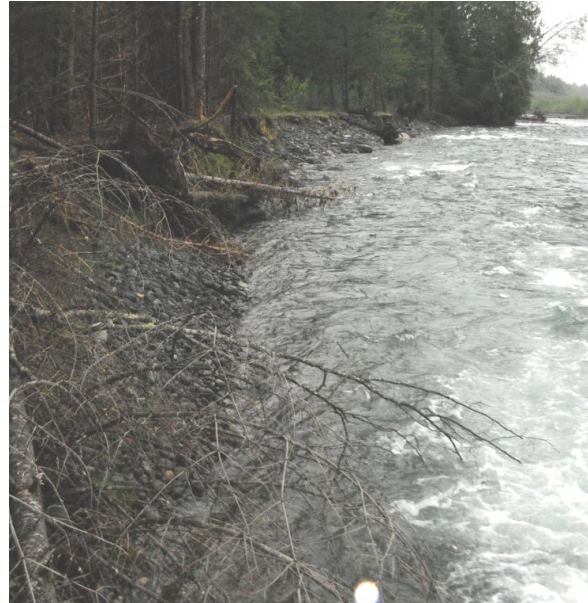
Vane 2 (background) and Vane 3 (foreground) areas have active toe erosion at normal flows.

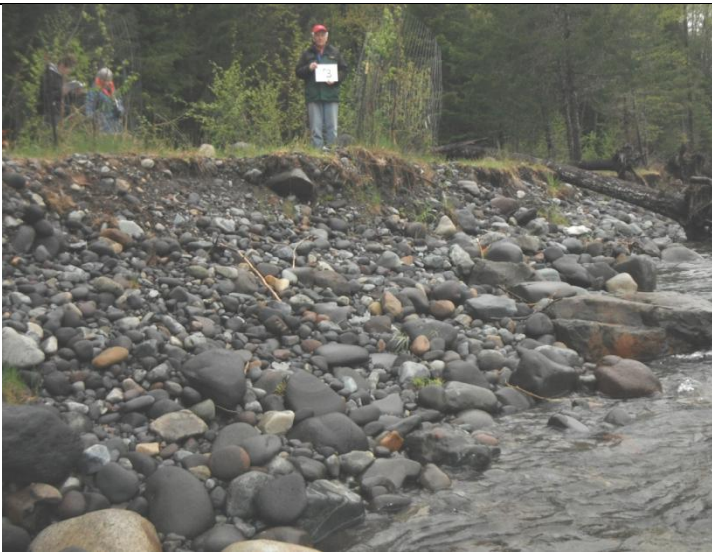
Vane 3 area is experiencing active toe erosion and slight exposure of the buried vane.

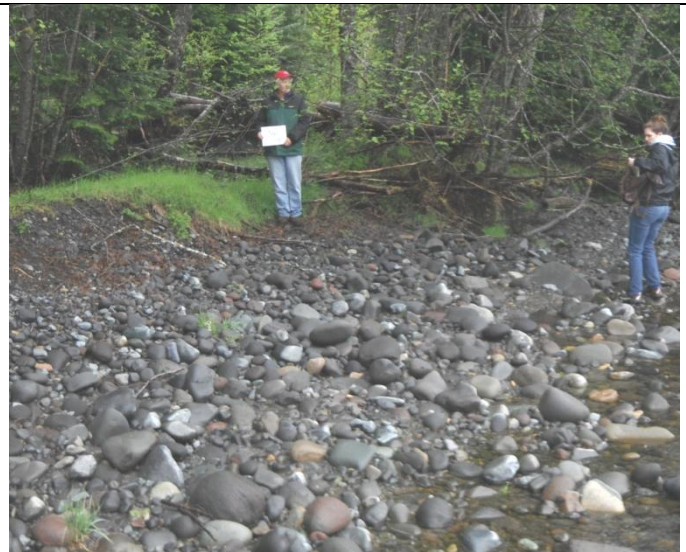
Vane 4 area is somewhat stable yet exposed to eroding flows at higher flow levels.

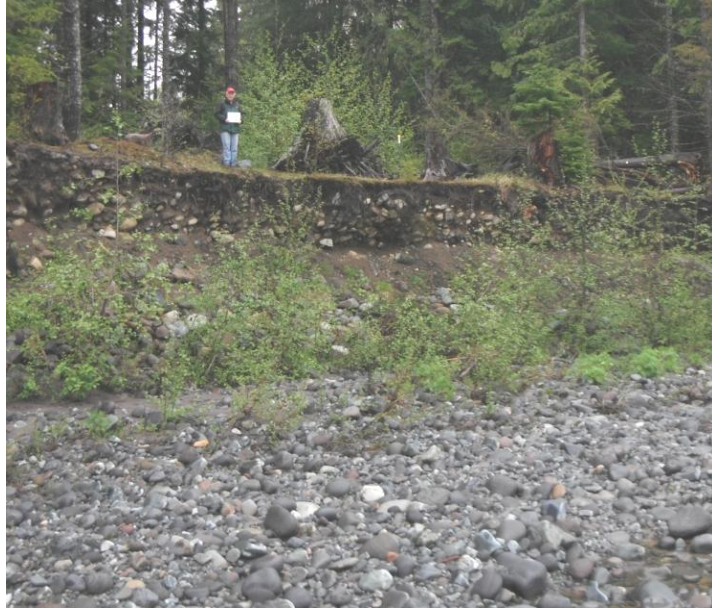
Vane 5 area is setback from the deepest part of the channel and although experiencing some chronic erosion at higher flows, over the last couple of years vegetation has established at the toe.

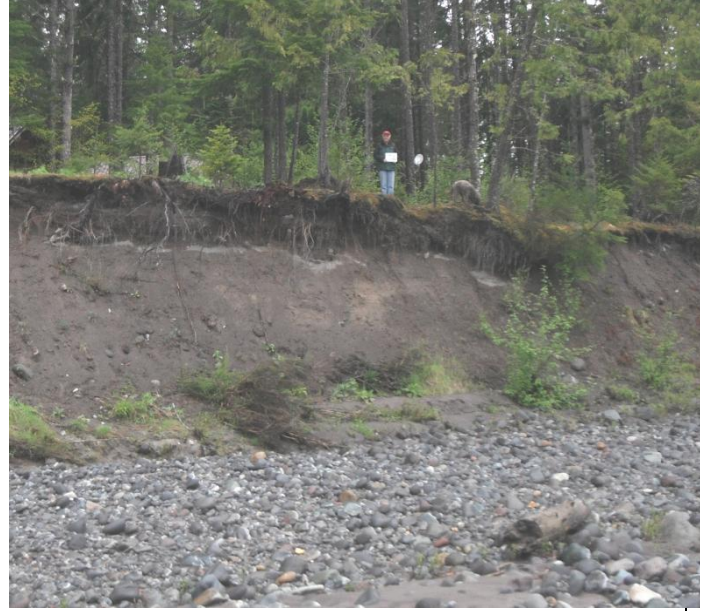
Vane 6 area contains some of the most at-risk, loosely consolidated soils and is an example of significance of other types of erosion than direct flows such as rain, wind, freeze-thaw, etc.

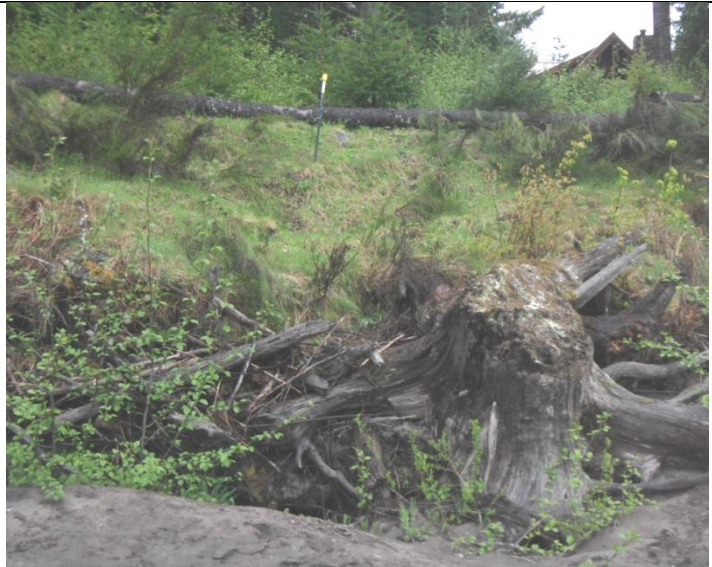
Vane 7 area although experiencing strong turbulent flows along the channel margin during flood events is the least actively-eroding site hosting vegetation growth and woody debris collection.

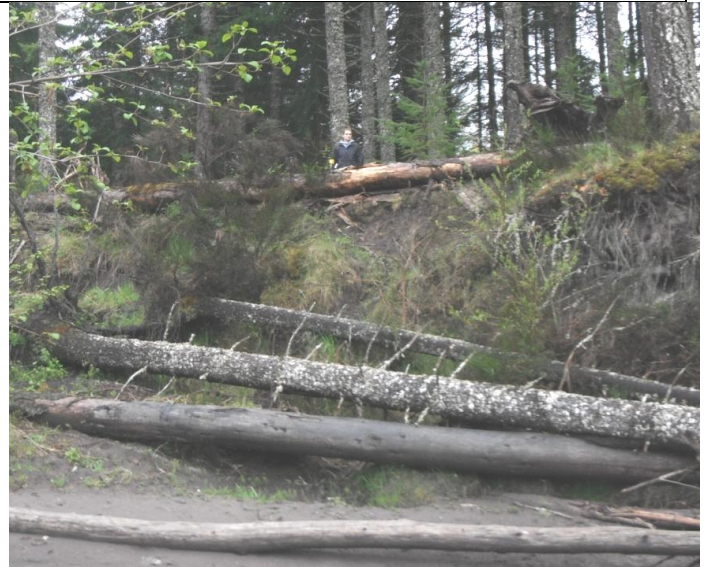
Vane 8 area has accumulated logs along the channel margin but they appear somewhat transient in nature. This vane area has also experienced one of the lowest erosion rates.

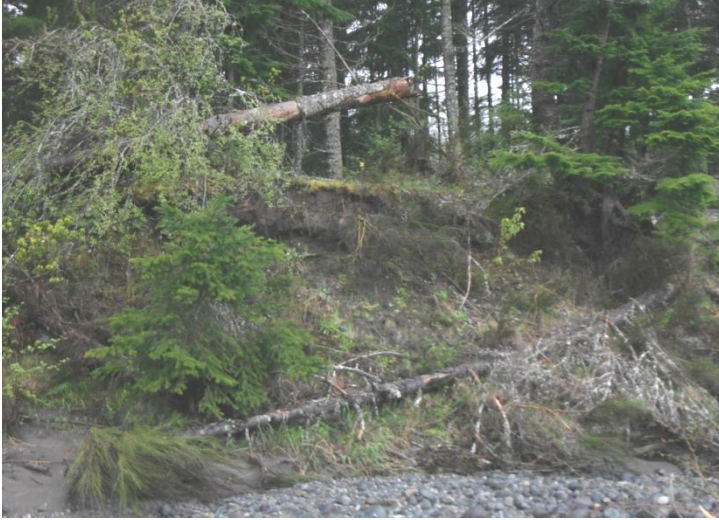
Vane 9 area is experiencing minimal erosion of the top of bank but has extensive undercut. The slower erosion rate relative to other areas may be aided by recruitment of non-tagged trees recruiting and positioning at the toe.

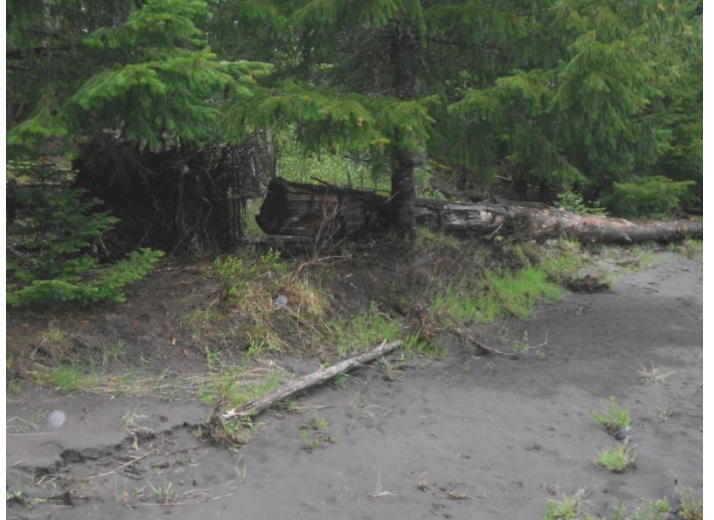
Vane 10 area has been largely unaffected through the evaluation. Fine sediment deposition occurs during flood stage due to downstream structure causing backwater. This area is a candidate for vegetation establishment before the downstream structures break apart and the backwatering effect is lost.

Vane Site 14 (above) and 10 (below) are reasonable candidates for fascine bundle placement and/or livestock planting. Both sites are removed from the deepest part of the channel, and dense rooting could be established within a couple of years. Green swaths suggest the location that rows of bundles and live stakes could be planted.

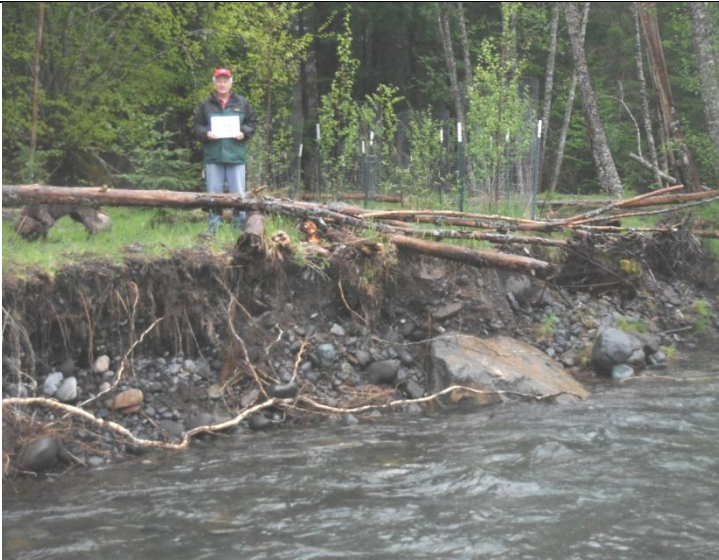
Vane 11 is exposed to flowing water at all river levels at this time and actively eroding. Portions of the buried vane are exposed as evidenced by the large boulder in the foreground.

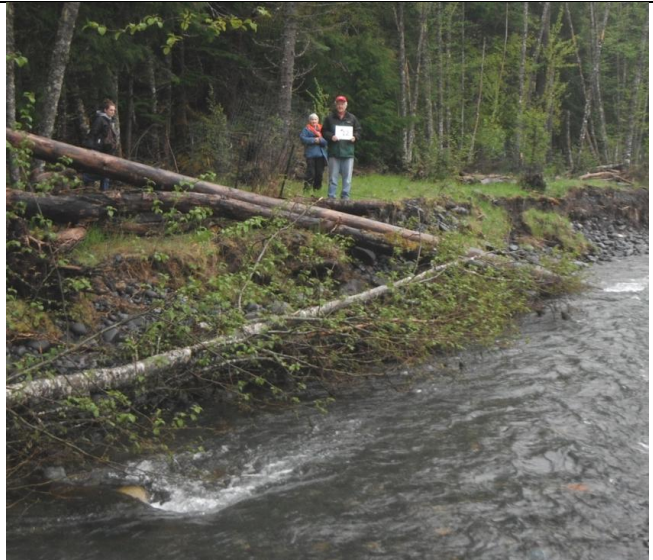
Vane 12 area has lost some tree markers due to erosion and is exposed to chronic toe erosion at normal flows. The site has some recruited wood along the toe but appears transient.

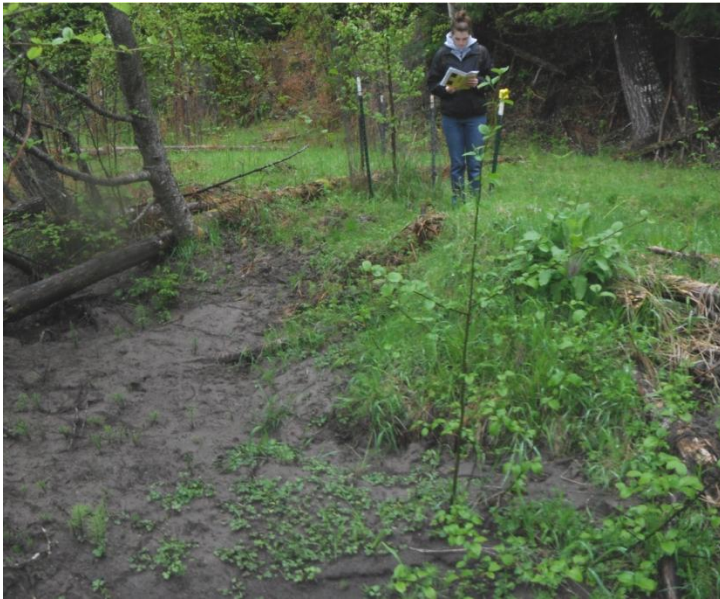
Vane 13 area remains setback from erosive flood channel flows protected by a young alder stand.

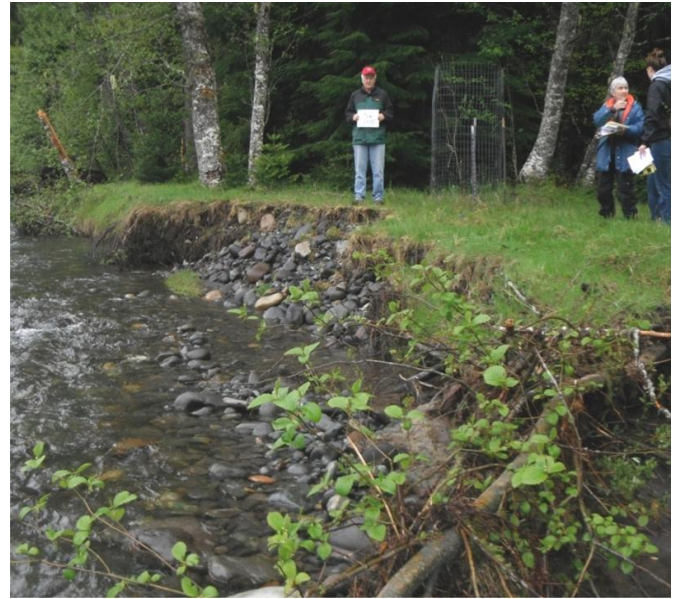
Vane 14 area is experiencing active toe erosion at normal flows. Loss of bank upstream is contributing to increased exposure and this area can be expected to see increased erosion rates in coming years.

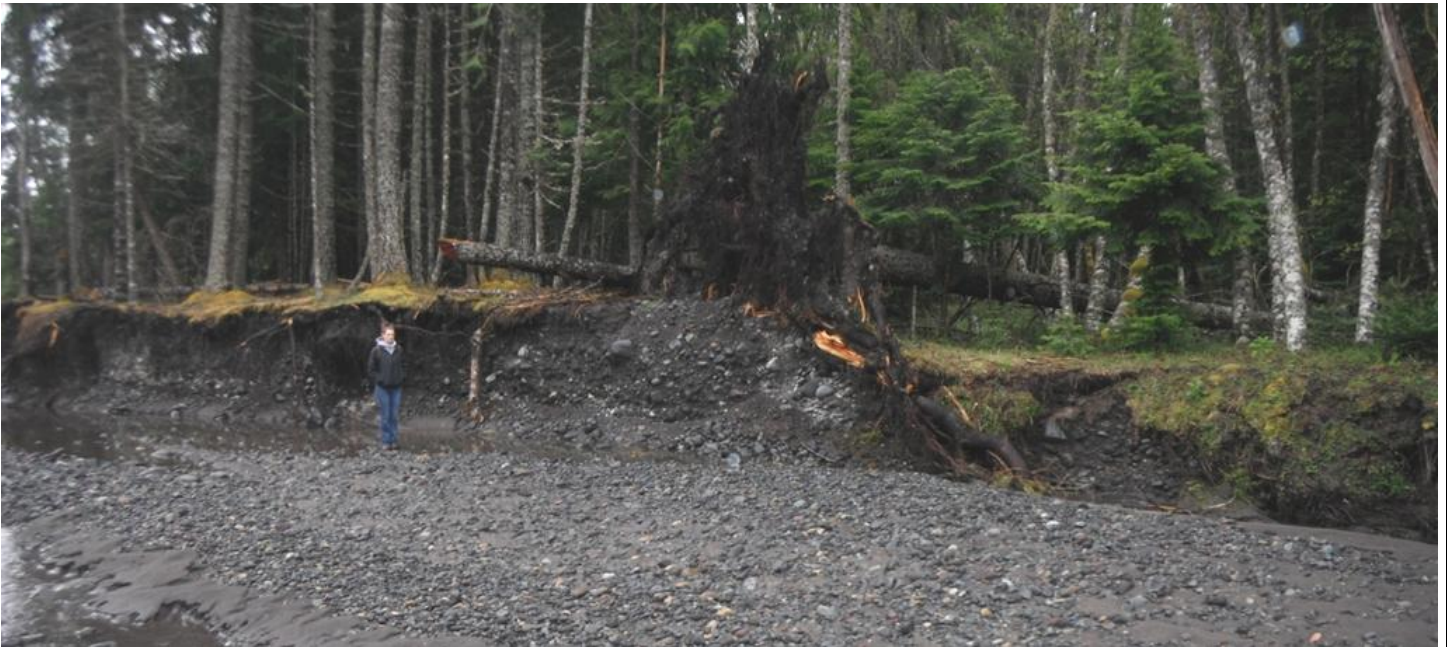
The area between vanes 12 and 13 is exposed to flowing water at flood levels and is highly undercutting. Newly fallen trees, large trees on undercut banks, loosely consolidated bank material and direction of flows during flood events make this area a candidate for severe erosion in coming years.

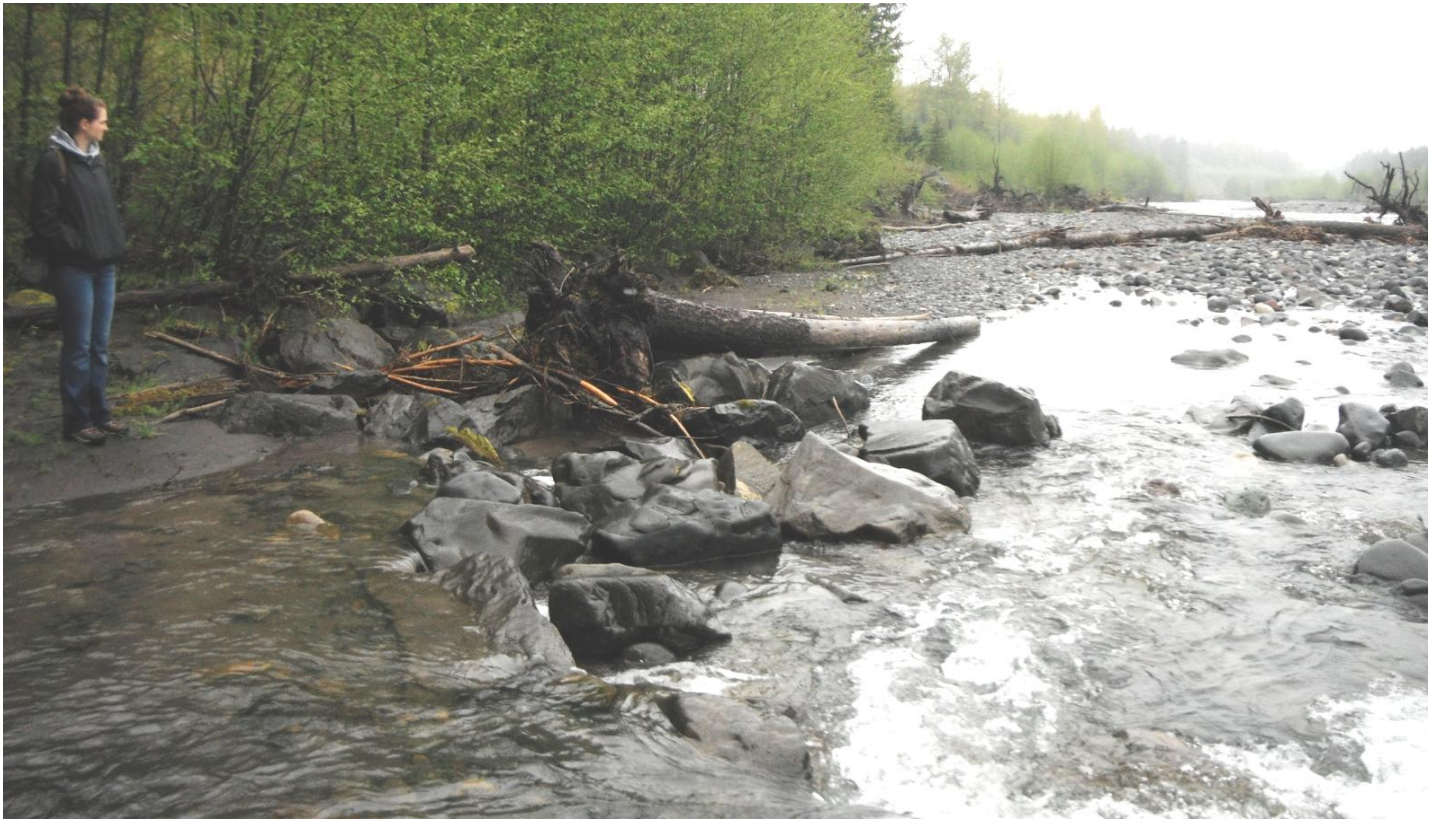
Habitat design engineer views a rock vane from a similar project in the area. The view is downstream with Crystal River Ranch properties on the uplands. The vane is functioning as designed by protecting the toe of the bank from high velocities during average flood flows. The backwatering area (foreground) and downstream eddying (background) that form during higher flows than pictured is settling out smaller than average substrate, trapping large and small woody debris and building bank along the channel margin where live fascine bundles had been planted about 10 years ago on a rapidly-eroding bank.
