MEMORANDUM

Subject: 2018 Vane Assessment Summary

On Wednesday August 22, 2018 KPFF conducted the annual shoreline erosion survey for Vanes 1-14 of Crystal River Ranch. We located all tree tags except for ones that were previously noted as gone or determined to be gone this date due to bank erosion. The field assessment resulted in the following summary:

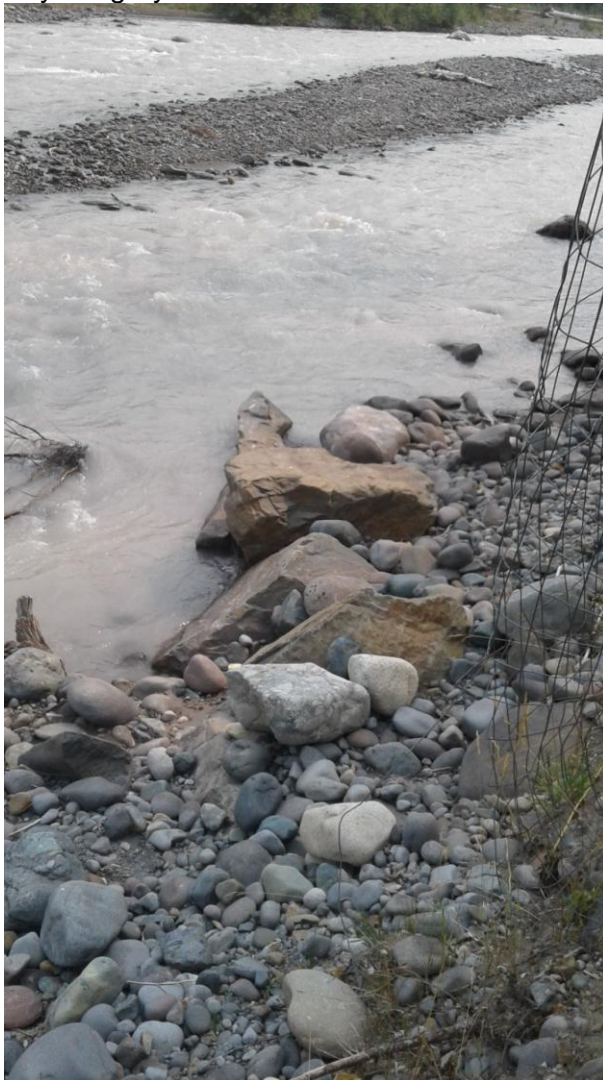
Vane 4 has a section of the vane exposed (larger angular rocks).

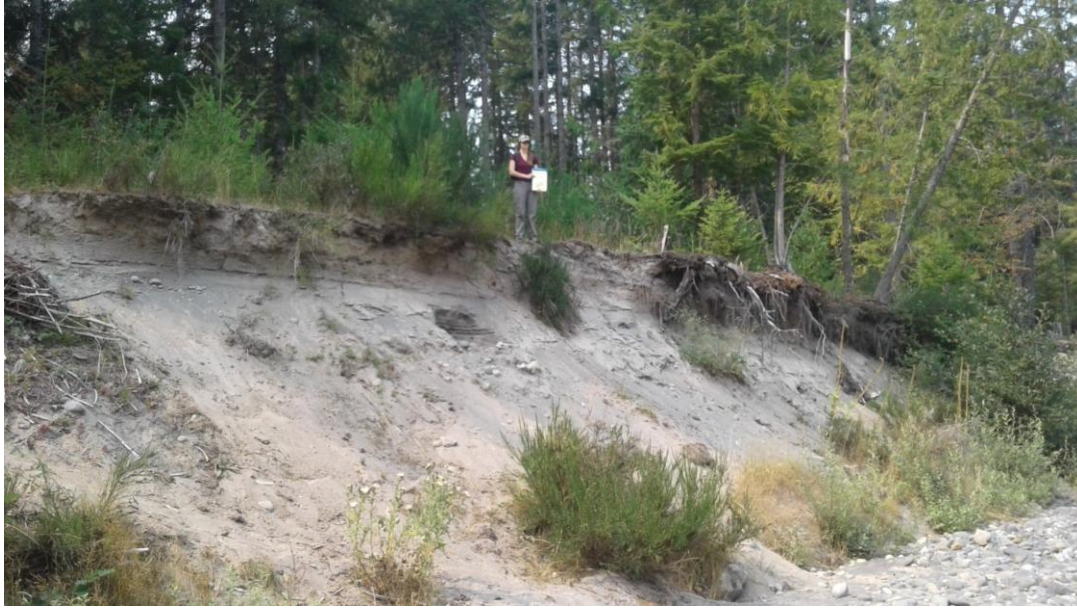
Vane 6 establishing vegetation at toe since flow has been less frequent at the toe over the past few years.

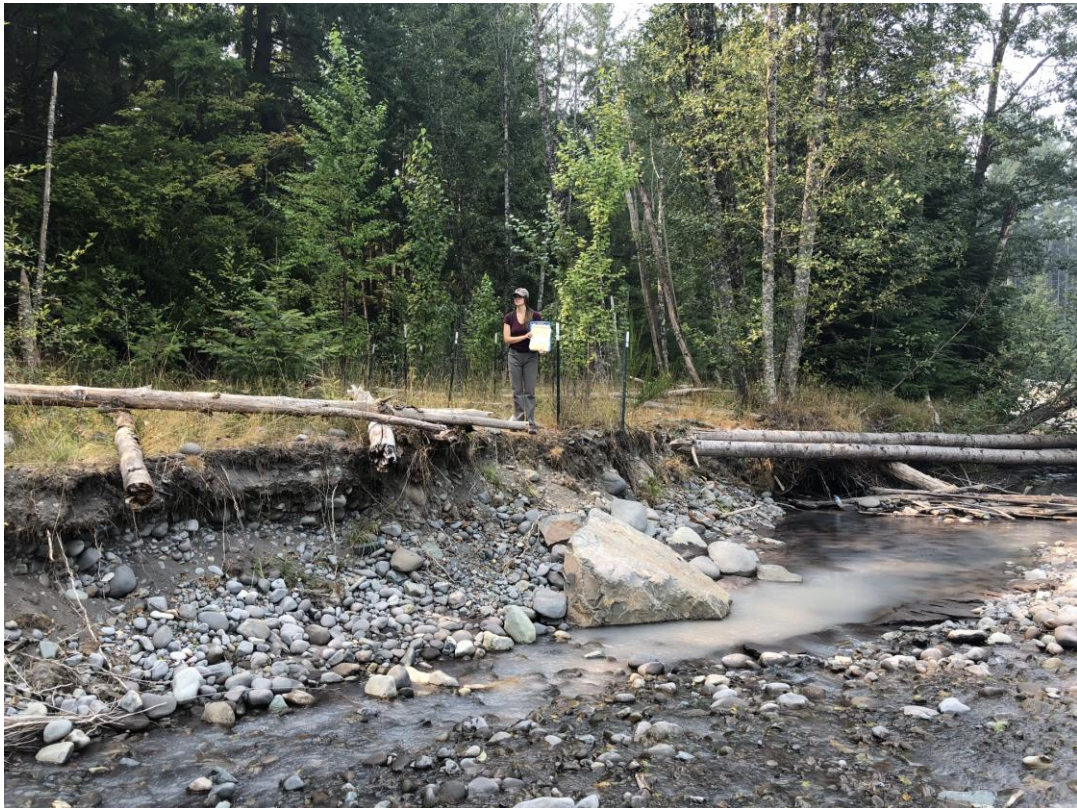
Vane 11 remains one of the highest eroding banks. Here note the large boulders that comprise the now-exposed vane. Toe erosion is contributing to large overhanging banks.
