Technical Memorandum

Crystal River Ranch White River Shoreline Assessment and Staff/Crest Gage Siting

Drafted November 9, 2012 Review / Edit February 9, 2013

To: Crystal River Ranch Executive Board
From: Lawrence Dominguez, Owner, Senior Aquatic Ecologist
RE: River Shoreline Assessment and Staff/Crest Gauge Recommendations

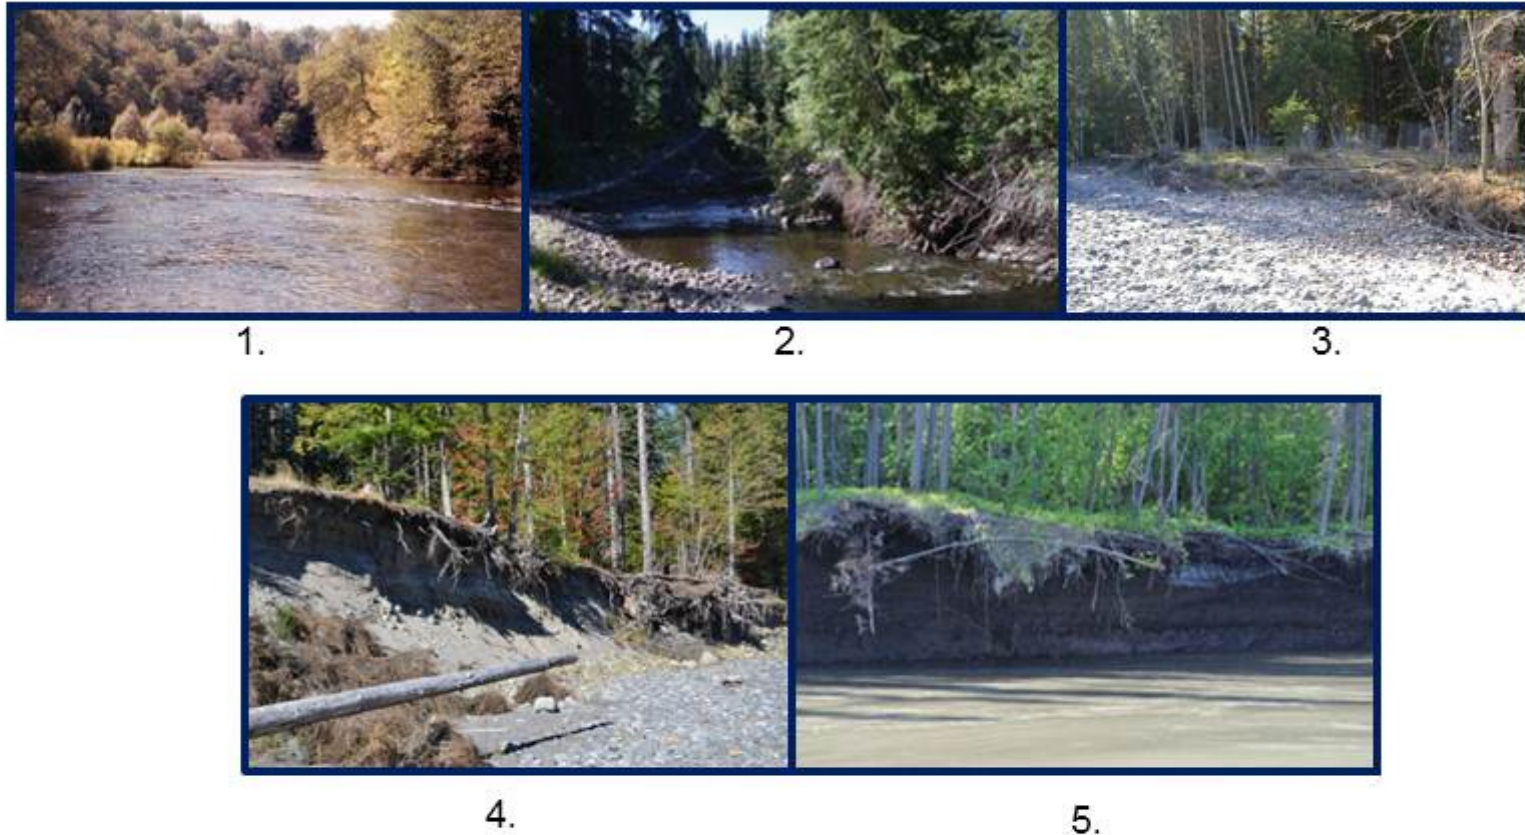
APPENDIX A – PHOTO REFERENCES FOR FUNCTIONAL RATING

Picture references for helping observers rate bank functionality and erosion trend will need to be developed over a couple of years period as the area of erosion is formally observed for trends. Rapidly-eroding banks could have a few years of recovery due to channel shifts, vegetation establishment, or woody debris collection. With this mix of White River shoreline images (3 and 4) and shorelines elsewhere (1, 2, 5), the images are consistent with the ratings definition from densely vegetated stable banks (1) to over-steepened bank with active erosion and active flows at the bank toe (5). Intermediate ratings (2.5, 3.5, etc.) can be used to capture uncertainty of the trend or impact and/or if the observed condition staggers the definitions of two ratings.
