Crystal River Ranch Upland Erosion Control Project

December 2014 CRR Restoration Status Report

PALS Permit No. 695650, Development Eng. File No. 56-15

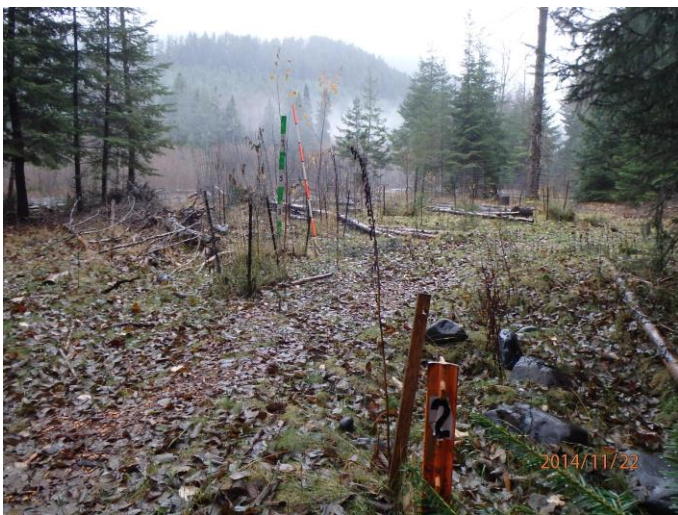
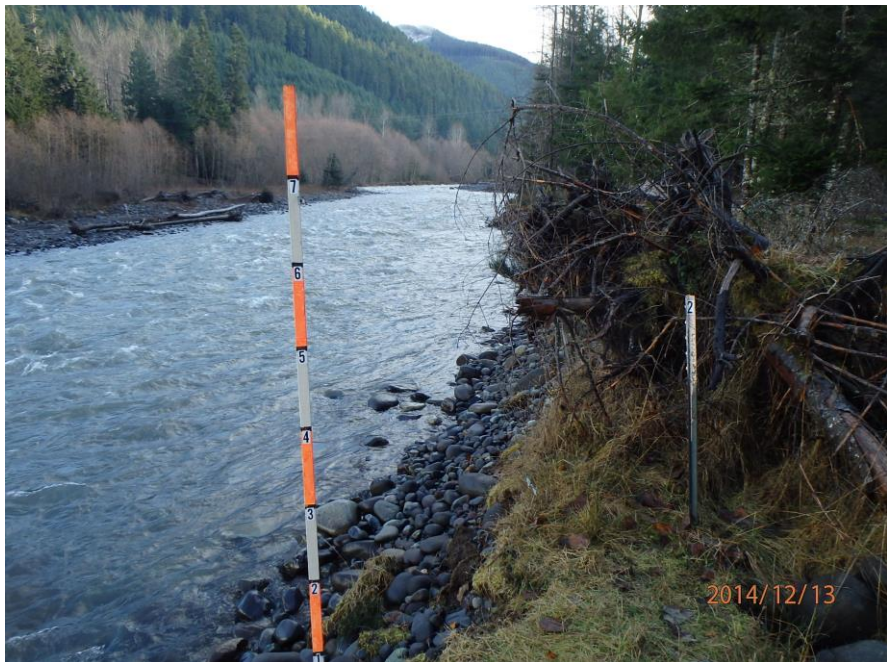
V2 Upstream12/13/2014

Doug fir	3-4 ft	Good	4	Planted Apr 2011 = 49	
Sitka willow	4 ft	Fair	1	Vane 2 plant survival exceeds 80%	
Birch	7-8 ft	Fair	4		
Birch	5-6 ft	Fair	5		
Alder	9-10 ft	Good	2		
Alder	7-8 ft	Good	7		
Alder	4-6 ft	Good	23		
Alder	2-3 ft	Good	17		
Live Plants:			63		Heel 11/22/2014
N 47° 06.518', W 121° 36.153' at shoreline vane stake. 3 Foot approximate OHW bank height.

Vane 2 live plants quantity 63 divided by planted April 2011 quantity 49 exceeds 80%+ survival

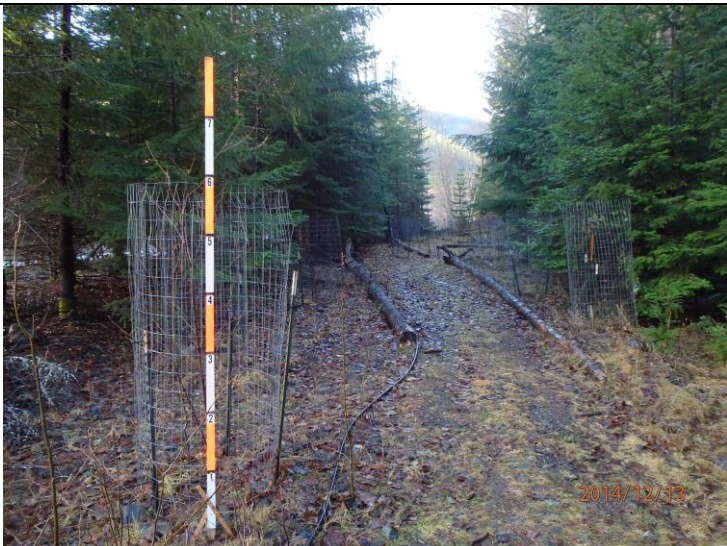
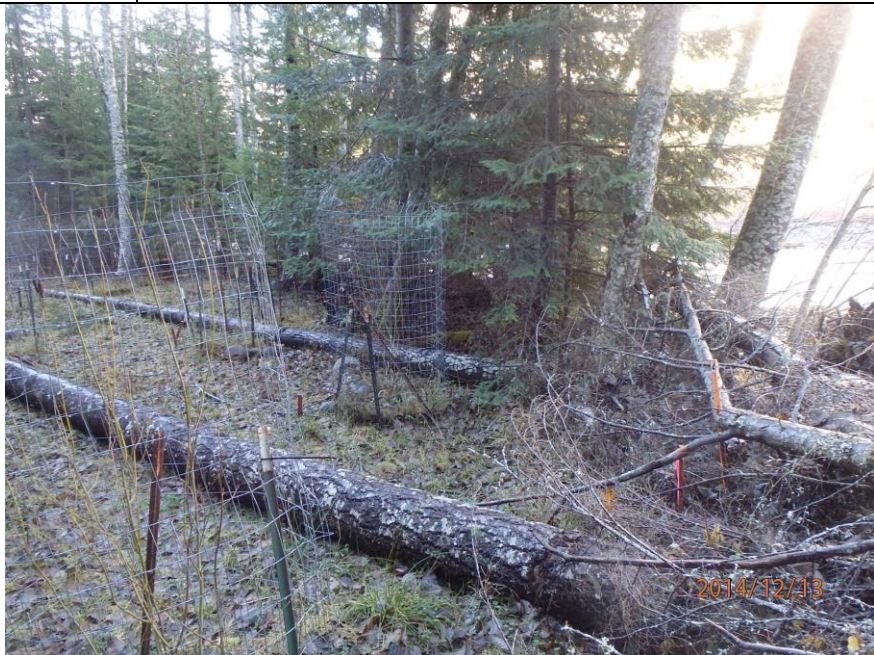
V4 Toe 12/13/2014

Access Route / Heel 12/13/2014
Sitka willow	4-5 ft	Fair	8	Planted Apr 2011 = 38	
Birch	7-8 ft	Fair	2	Vane 4 plant survival exceeds 80%	
Birch	5-6 ft	Fair	17		
Alder	7-8 ft	Good	2		
Alder	4-6 ft	Good	33		
Alder	2-3 ft	Good	29		
Live Plants:			91		
N 47° 06.531', W 121° 36.072' at shoreline stake (toe) of vane. 3 Foot approximate OHW (ordinary high water) bank height.

Vane 4 live plants quantity 91 divided by planted April 2011 quantity 38 exceeds 80%+ survival

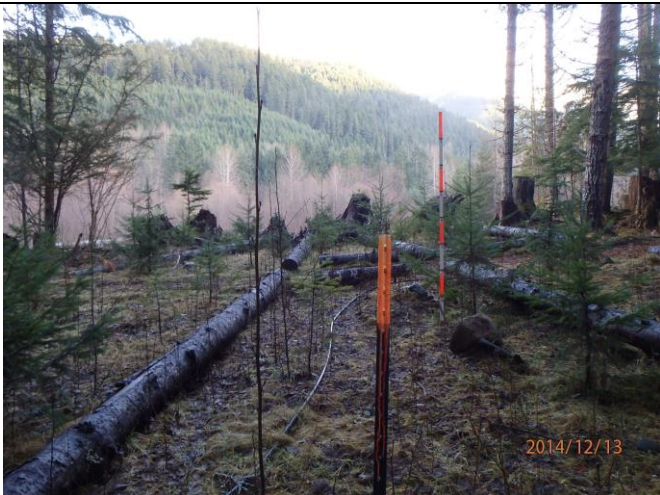
<div>2014/12/13</div> <div>V5 Heel 12/13/2014</div>
Doug fir, Sitka spruce, Hemlock	7-8 ft	Good	16		
Doug fir, Sitka spruce, Hemlock	4-6 ft	Good	49		
Doug fir, Sitka spruce, Hemlock	2-3 ft	Good	13		
Alder	4-6 ft	Good	26		
Alder	2-3 ft	Good	19		
Live Plants:			123		
N 47° 06.487', W 121° 36.052' at shoreline vane stake. > 16 Foot OHW bank height.

Vane 5 live plants quantity 123 divided by planted April 2011 quantity 112 exceeds 80%+ survival

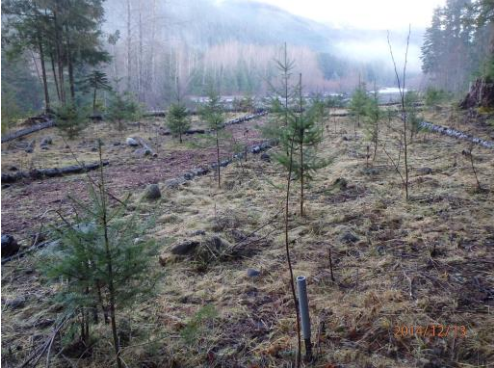
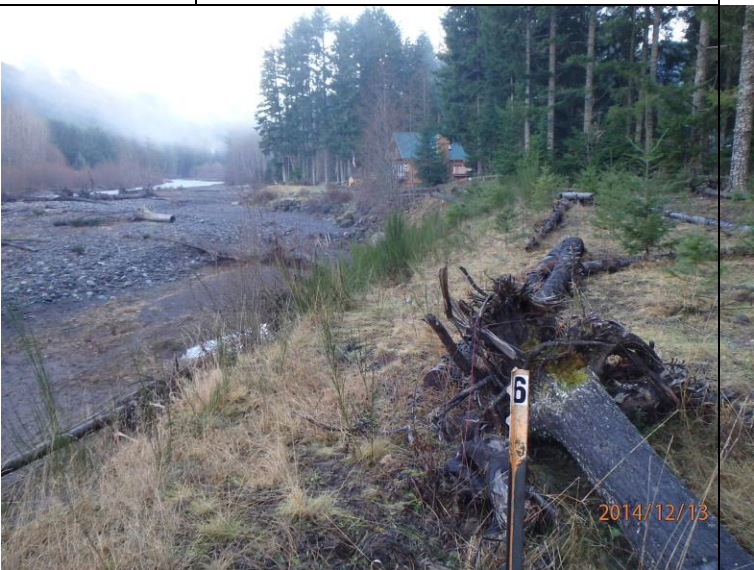
V6 Upstream 12/13/2014

Doug fir, Sitka spruce, Hemlock	7-8 ft	Good	8	Planted Apr 2011 = 106	
Doug fir, Sitka spruce, Hemlock	4-6 ft	Good	42	Vane 6 plant survival exceeds 80%	
Doug fir, Sitka spruce, Hemlock	2-3 ft	Good	35		
Alder	4-6 ft	Good	20		
Alder	2-3 ft	Good	24		
Live Plants:			129	Heel 12/13/2014	
N 47° 06.459', W 121° 36.048' at shoreline vane stake. > 16 Foot OHW bank height.

Vane 6 live plants quantity 129 divided by planted April 2011 quantity 106 exceeds 80%+ survival

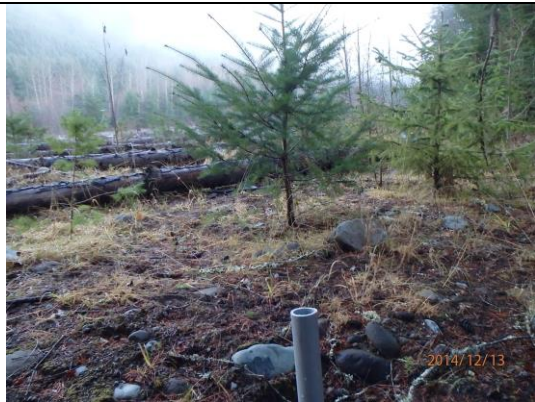
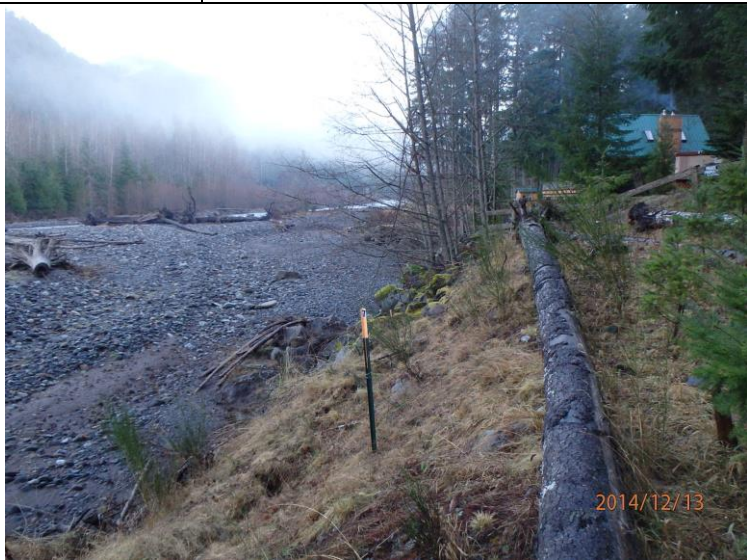
V7 Upstream 12/13/2014

Heel 12/13/2014
Doug fir, Sitka willow, Hemlock	7-8 ft	Good	3	Planted Apr 2011 = 100	
Doug fir, Sitka willow, Hemlock	4-6 ft	Good	32	Vane 7 plant survival exceeds 80%	
Doug fir, Sitka willow, Hemlock	2-3 ft	Good	39		
Alder	4-6 ft	Good	8		
Alder	2-3 ft	Good	14		
Live Plants:			96		
N 47° 06.435', W 121° 36.037' at shoreline vane stake. > 16 Foot OHW bank height.

Vane 7 live plants quantity 96 divided by planted April 2011 quantity 100 = 96%+ survival

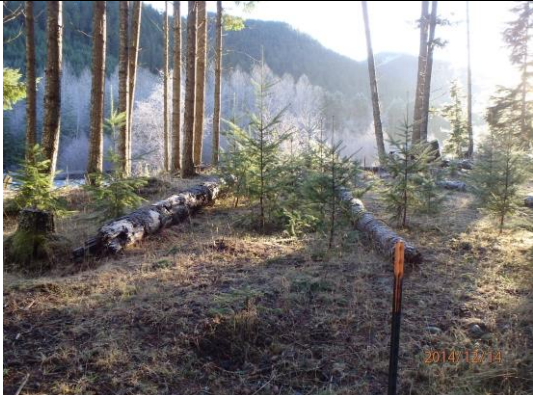
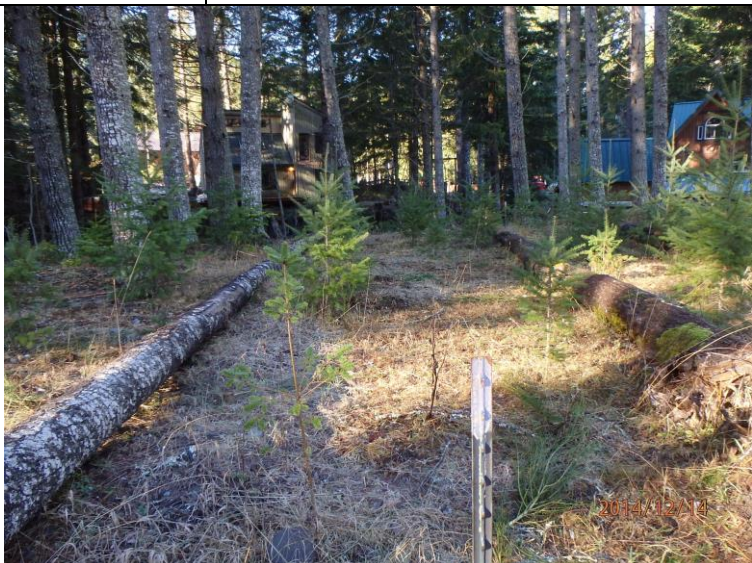
V8 Toe 12/14/2014

Heel 12/14/2014
Doug fir, Sitka spruce, Hemlock	7-8 ft	Good	8	Planted Apr 2011 = 66	
Doug fir, Sitka spruce, Hemlock	4-6 ft	Good	38	Vane 8 plant survival exceeds 80%	
Doug fir, Sitka spruce, Hemlock	2-3 ft	Good	21		
Live Plants:			67		
N 47° 06.381', W 121° 35.000' at shoreline vane stake. > 10 Foot OHW bank height.

Vane 8 live plants quantity 67 divided by planted April 2011 quantity 66 exceeds 80%+ survival

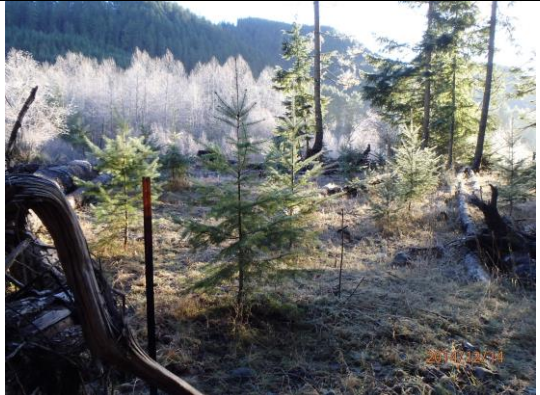
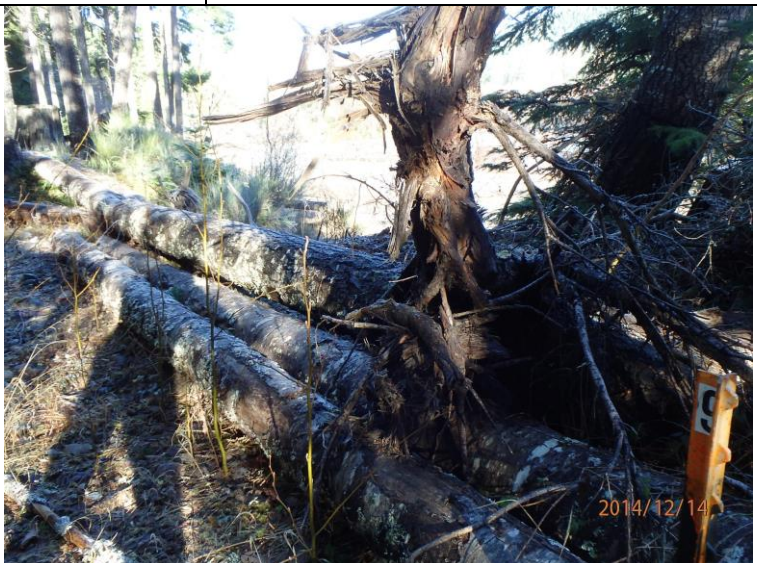
V9 Toe Downstream 12/14/2014

Heel 12/14/2014
Doug fir, Sitka spruce, Hemlock	7-8 ft	Good	12	Planted Apr 2011 = 66	
Doug fir, Sitka spruce, Hemlock	4-6 ft	Good	33	Vane 9 plant survival exceeds 80%	
Doug fir, Sitka spruce, Hemlock	2-3 ft	Good	19		
Live Plants:			64		
N 47° 06.369', W 121° 35.982' at shoreline vane stake. > 10 Foot OHW bank height.

Vane 9 live plants quantity 64 divided by planted April 2011 quantity 66 = 96% survival

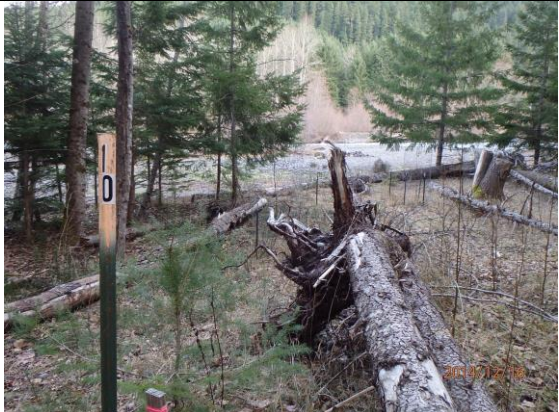
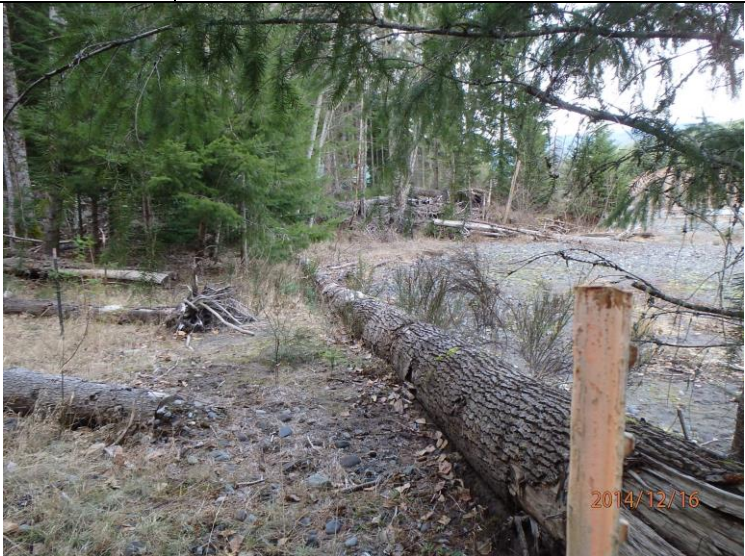
V10 Toe 12/16/2014

Heel 12/16/2014
Birch	7-8 ft	Fair	1	Planted Apr 2011 = 22	
Birch	4-6 ft	Fair	1	Vane 10 plant survival exceeds 80%	
Doug fir, Sitka spruce, Hemlock	4-6 ft	Good	3		
Doug fir, Sitka spruce, Hemlock	2-3 ft	Good	3		
Alder	4-6 ft	Good	12		
Alder	2-3 ft	Good	21		
Live Plants:			41		
N 47° 06.346', W 121° 35.971' at shoreline vane stake. 3 Foot OHW bank height.

Vane 10 live plants quantity 41 divided by planted April 2011 quantity 22 exceeds 80%+ survival

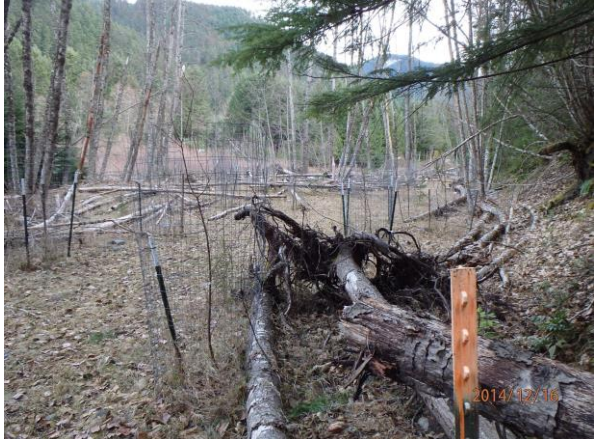
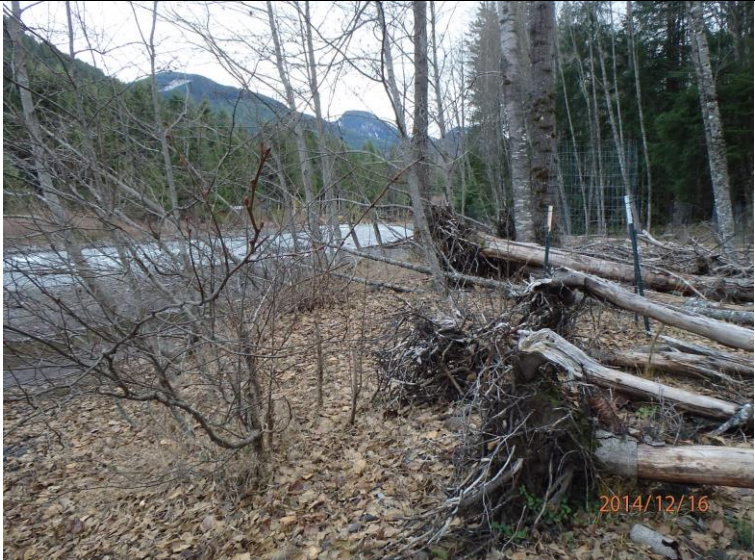
V11 Toe 12/16/2014

Heel 12/16/2014
Sitka willow	2-3 ft	Fair	2	Planted Apr 2011 = 55	
Birch	7-8 ft	Fair	5	Vane 11 plant survival exceeds 80%	
Birch	4-6 ft	Fair	10		
Doug fir, Sitka willow, Hemlock	4-6 ft	Good	3		
Doug fir, Sitka willow, Hemlock	2-3 ft	Good	15		
Alder	4-6 ft	Good	1		
Alder	2-3 ft	Good	9		
Live Plants:			45		
N 47° 06.332', W 121° 35.935' at shoreline vane stake. 1 to 2 Foot OHW bank height.

Vane 11 live plants quantity 45 divided by planted April 2011 quantity 55 = 81% survival

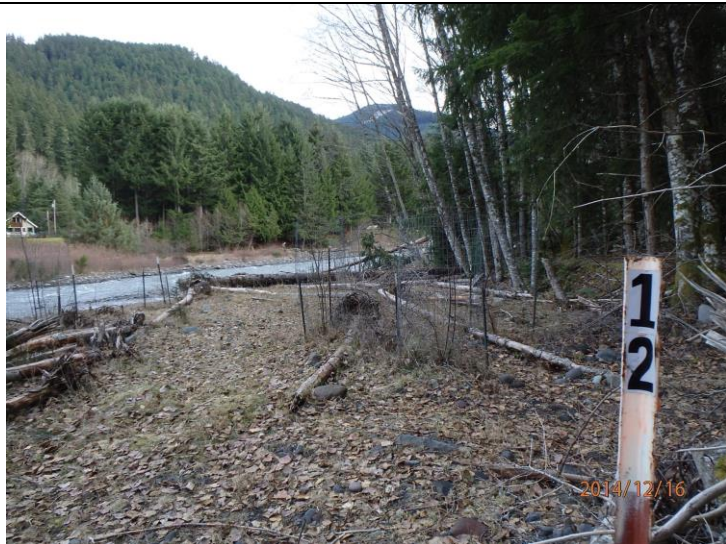
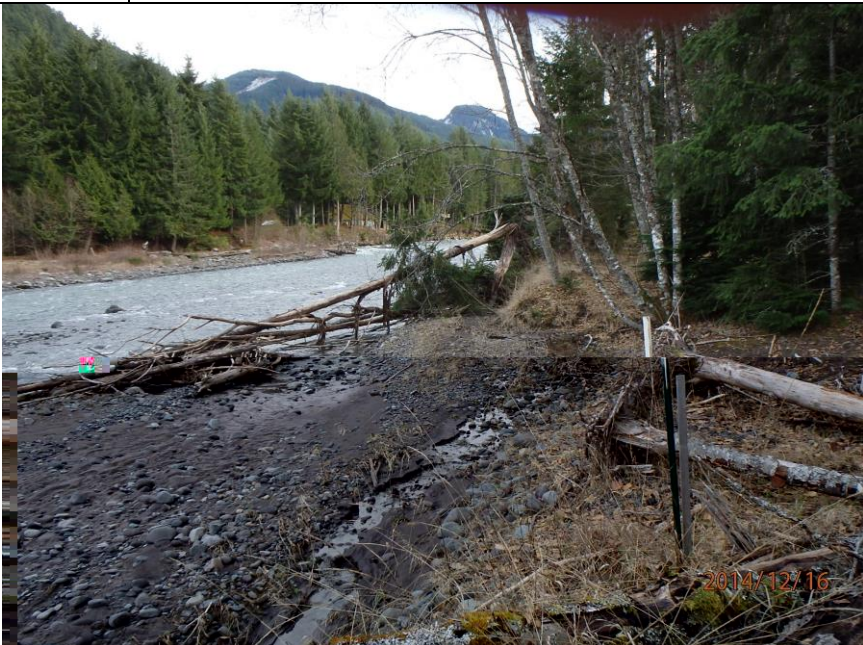
<p>2014/12/16</p> <p>V12 Toe12/16/2014</p>	
2 to 3 Foot OHW bank height.

<p>2014/12/16</p> <p>Heel 12/16/2014</p>
Doug fir	4-6 ft	Good	2		
Doug fir	2-3 ft	Good	6	Planted Apr 2011 = 25	
Birch	7 ft	Good	1	Vane 12 plant survival exceeds 80%	
Birch	5-6 ft	Good	5		
Sitka willow	4-6 ft	Fair	2		
Sitka willow	2-3 ft	Fair	2		
Alder	2-3 ft	Good	4		
Live Plants:			22		
N 47° 06.305', W 121° 35.918' at shoreline vane stake.

Vane 12 live plants quantity 22 divided by planted April 2011 quantity 25 = 88%+ survival

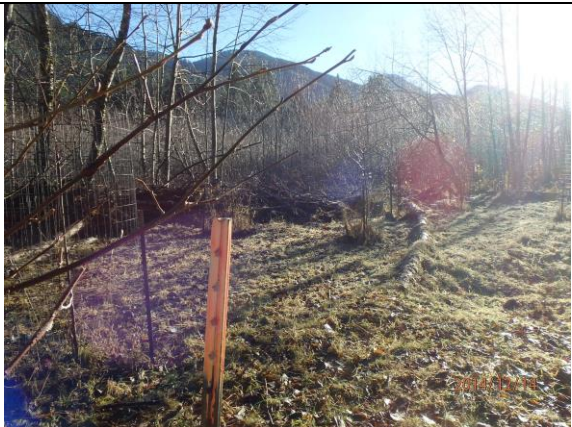
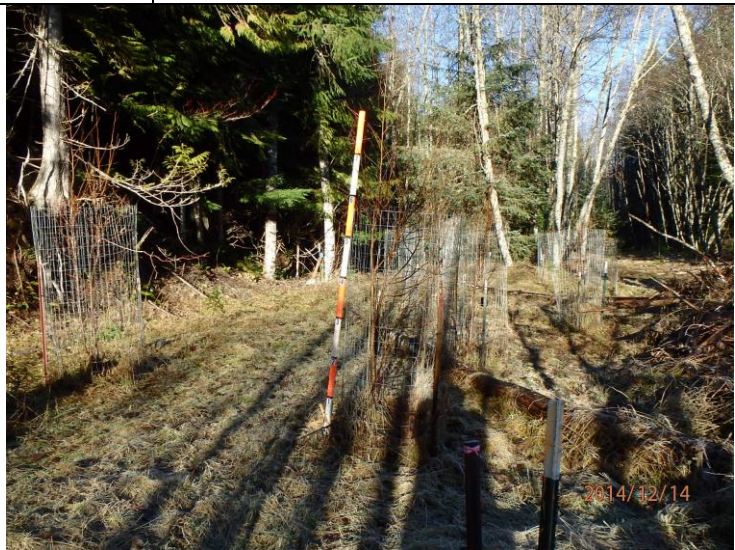
V13 Toe 12/14/2014

Birch	7-8 ft	Good	7	Planted Apr 2011 = 15	
Birch	4-6 ft	Good	5	Vane 13 plant survival exceeds 80%	
Doug fir	2-3 ft	Good	2		
Alder	2-3 ft	Good	1		
Live Plants:			15		Heel 12/14/2014
N 47° 06.319', W 121° 35.923' at shoreline vane stake. 3 Foot OHW bank height.

Vane 13 live plants quantity 15 divided by planted April 2011 quantity 15 = 100%+ survival

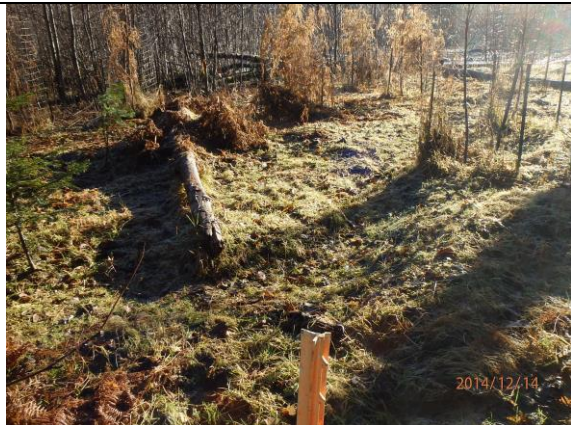
Sitka willow	4-6 ft	Fair	4	Planted Apr 2011 = 24	
Birch	10-12 ft	Good	8	Vane 14 plant survival exceeds 80%	
Birch	6-7 ft	Good	6		
Doug fir	4-6 ft	Good	3		
Alder	4-6 ft	Good	2		
Alder	2-3 ft	Good	5		
Live Plants:			28		
<p>N 47° 06.148', W 121° 35.395' at shoreline vane stake. Furthest upstream inland rock vane. At site main channel bends West to East.</p> <p>3 Foot OHW bank height.</p> <p>18 ft - 20 ft shoreline erosion since 2010. A vane toe rock exposed. One mature shoreline alder lost 2014 and another mature alder in upstream proximity leaning over channel.</p>
