## TECHNICAL MEMORANDUM

September 13, 2014

RE: Vane Monitoring Reference Point and Top of Undisturbed Left and Right Bank Survey, Crystal River Ranch Reach White River, Pierce County, WA

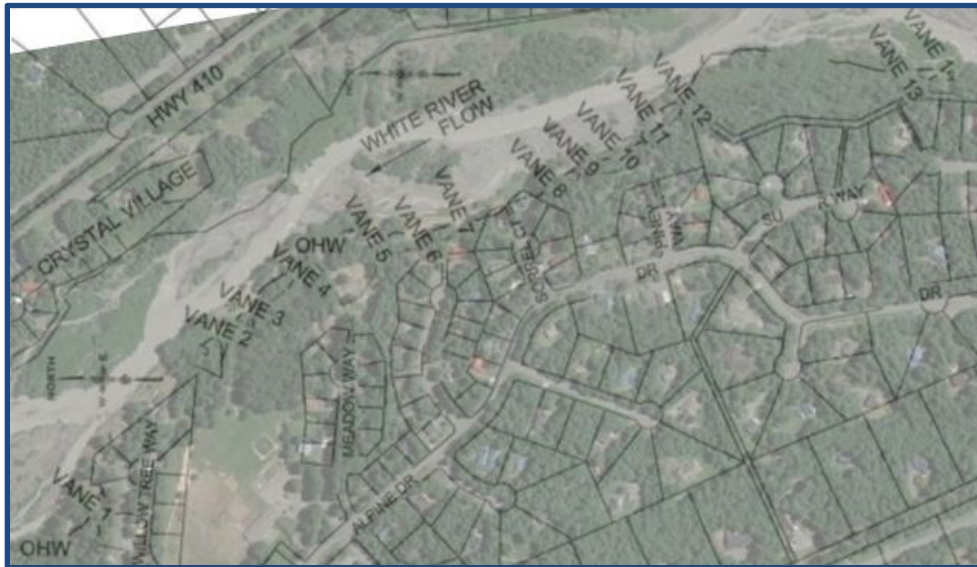
Figure 1 General locations of vanes 1 -14 on White River's western shoreline. River flow is right to left.

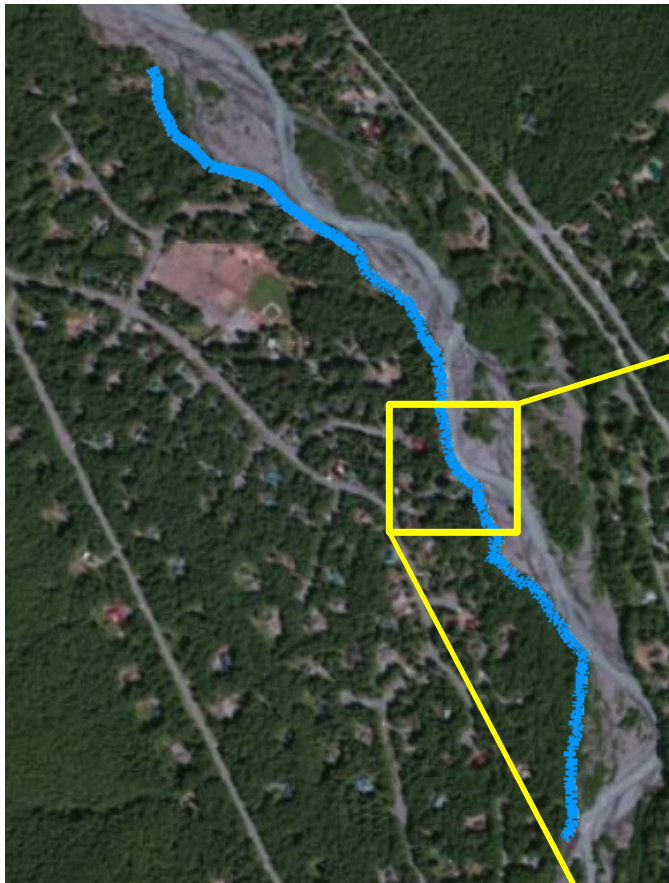
**Top of Undisturbed Bank based on  
Waypoint and Tracks Nov 2013 and Apr 2014  
White River, Pierce Co., WA**  
(Locations approximate based on GPS coordinates and remote imagery )

Blue line represents a composite of all GPS points from November 2013 top of undisturbed bank survey. Top of undisturbed bank survey is repeatable and can be compared over time to estimate the erosion rate.
